November 23, 2021

Re: Slope Stability Study – 426 Carveth's Marina Road, Lakefield
Cambium Reference: 12908-002

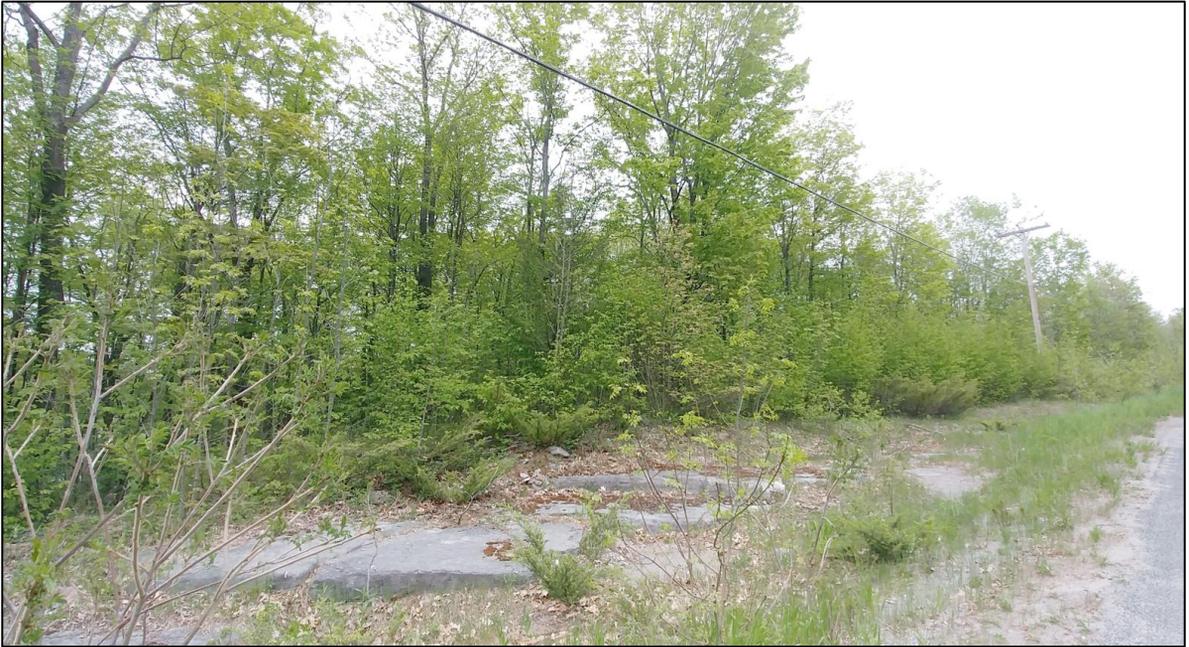
Photo 1: Exposed limestone on the south side of the property – north side of Birchview Road. Dense trees and brush immediately north of the road.

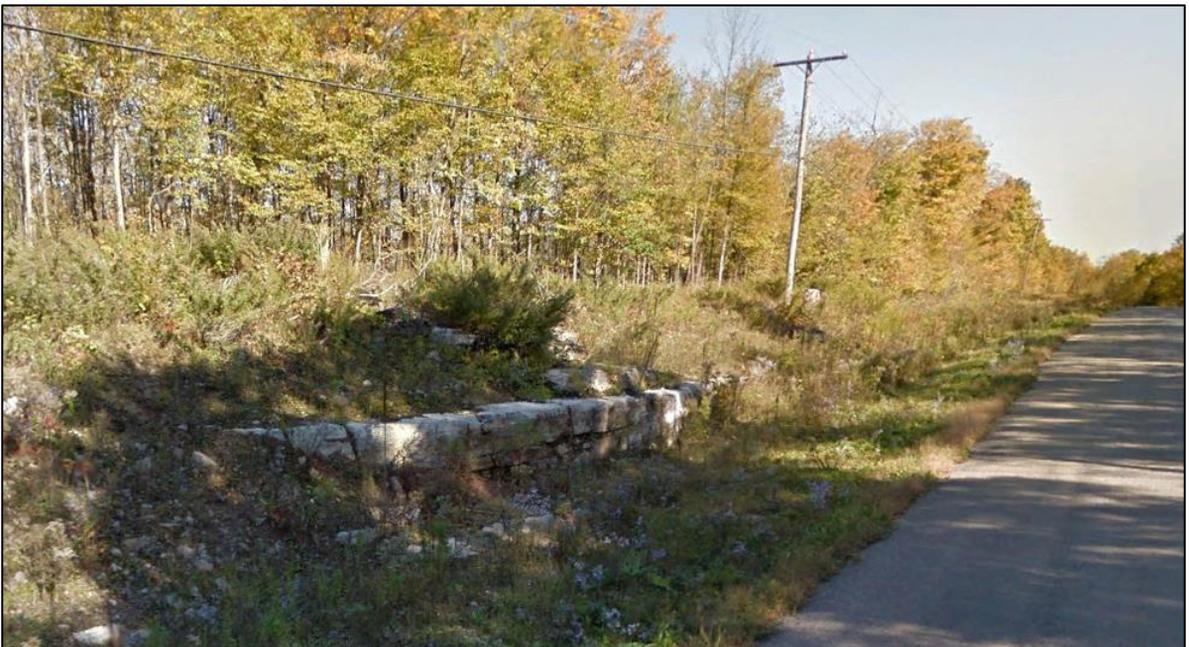
Photo 2: Exposed limestone on the south side of the property – north side of Birchview Road. Slight incline from the road north into the proposed lots.

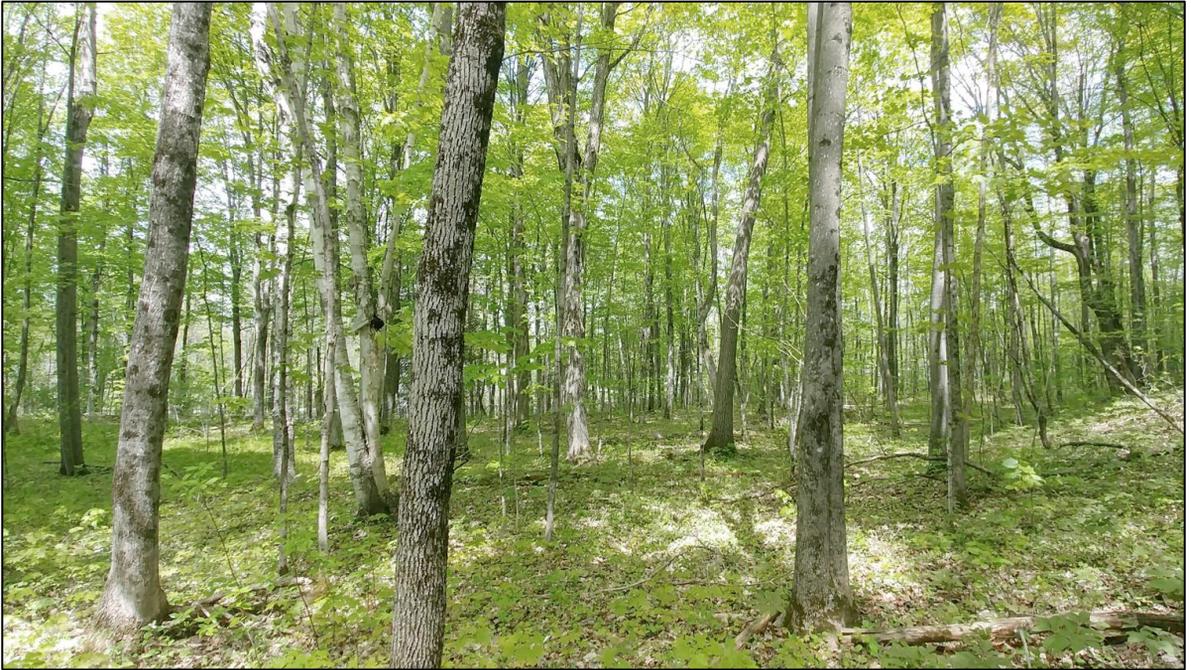
Photo 3: Dense hardwood forest in table flat land atop the slope, within the proposed lots. Grasses and weeds present throughout

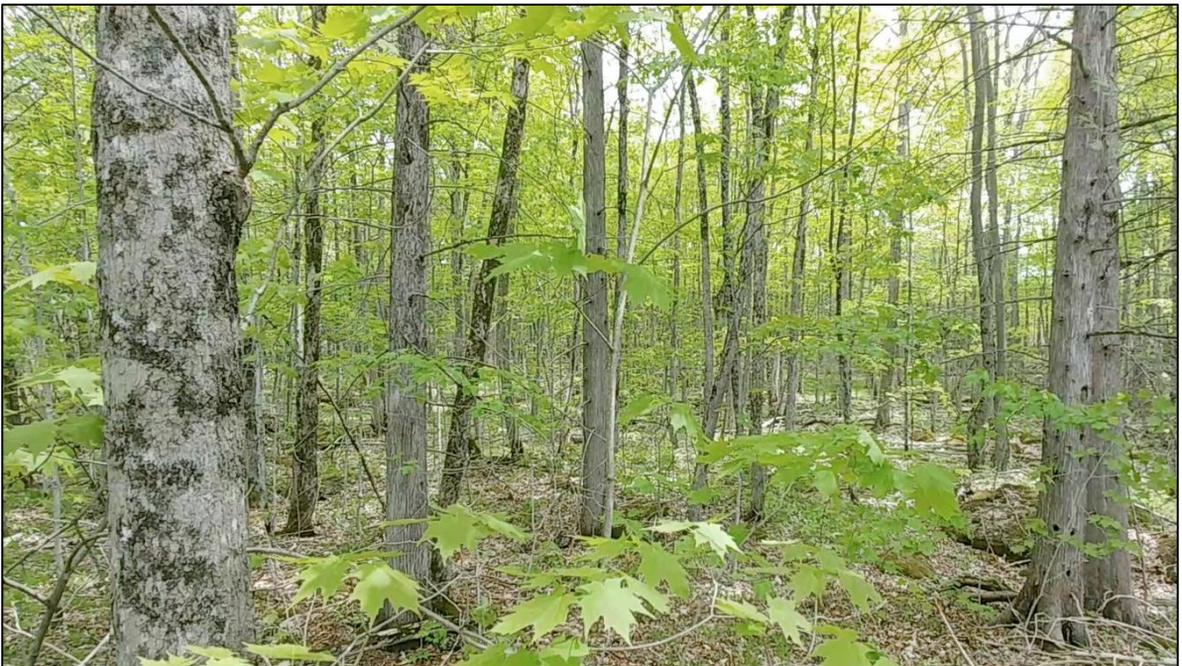
Photo 4: Another view of dense hardwood forest on table flat land. Some brush within the forest along with grass and weeds. Roots of tree in bottom right of photo are growing on bedrock and exposed bedrock is visible immediately behind the tree.

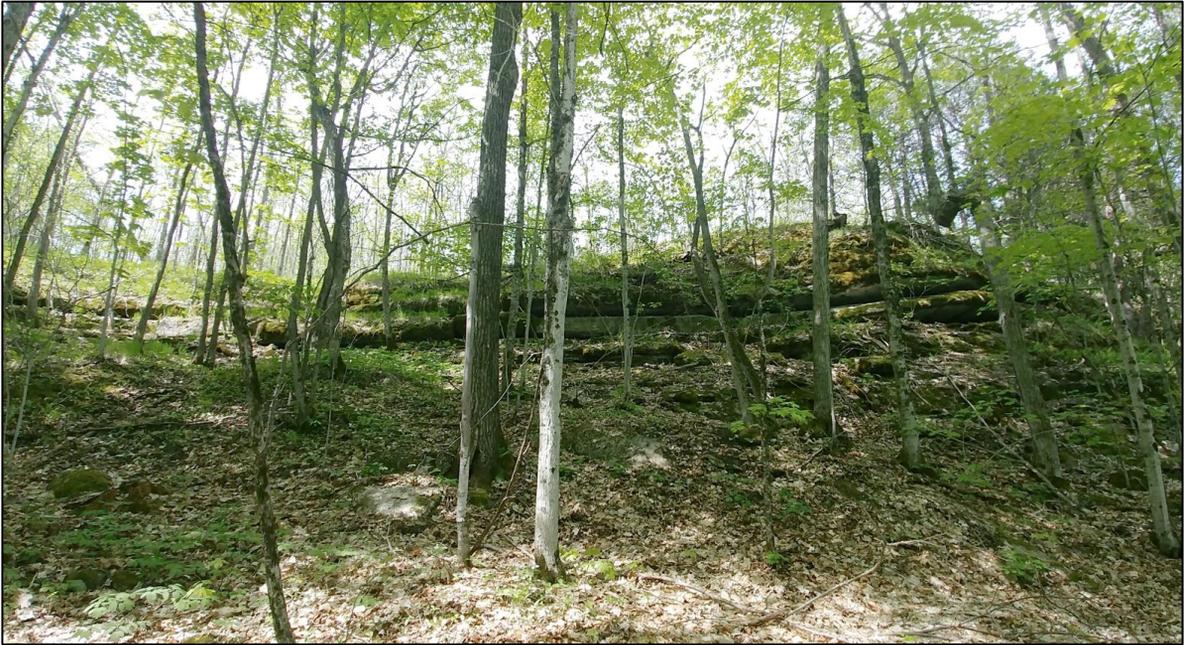
Photo 5: Limestone escarpment on the north side of the west lot, looking up from below.

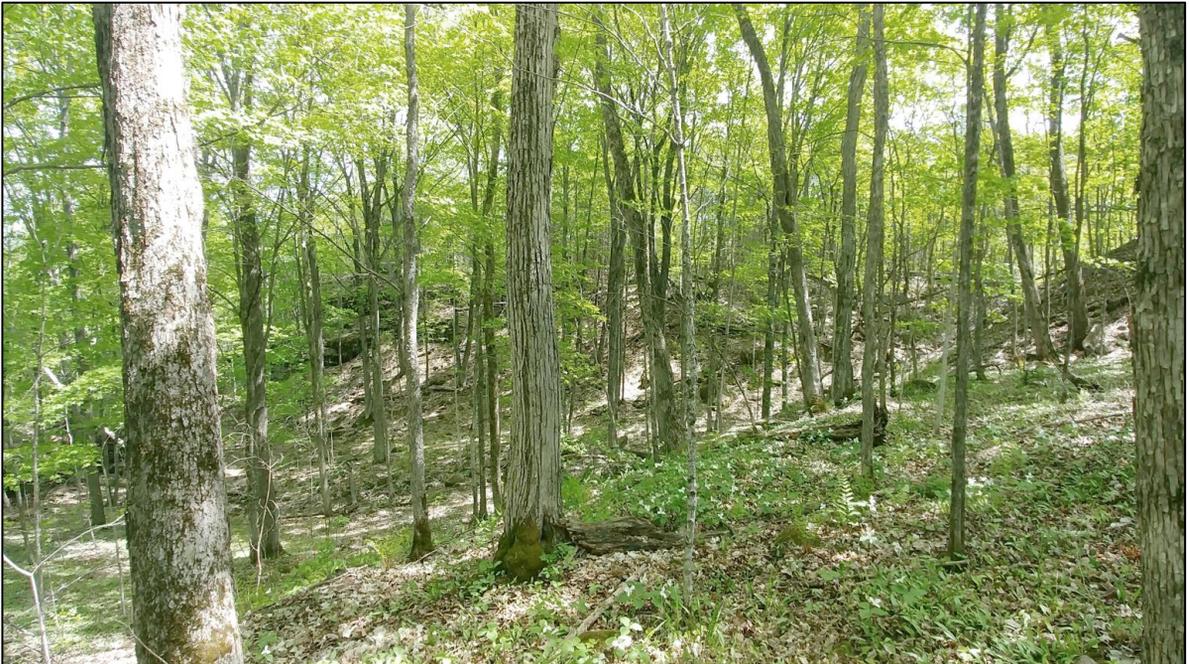
Photo 6: View of slope from base. The escarpment protrudes to the south in the right of the of the photo and in the middle of the photo. The escarpment is less significant between the two and the slope is more constant.

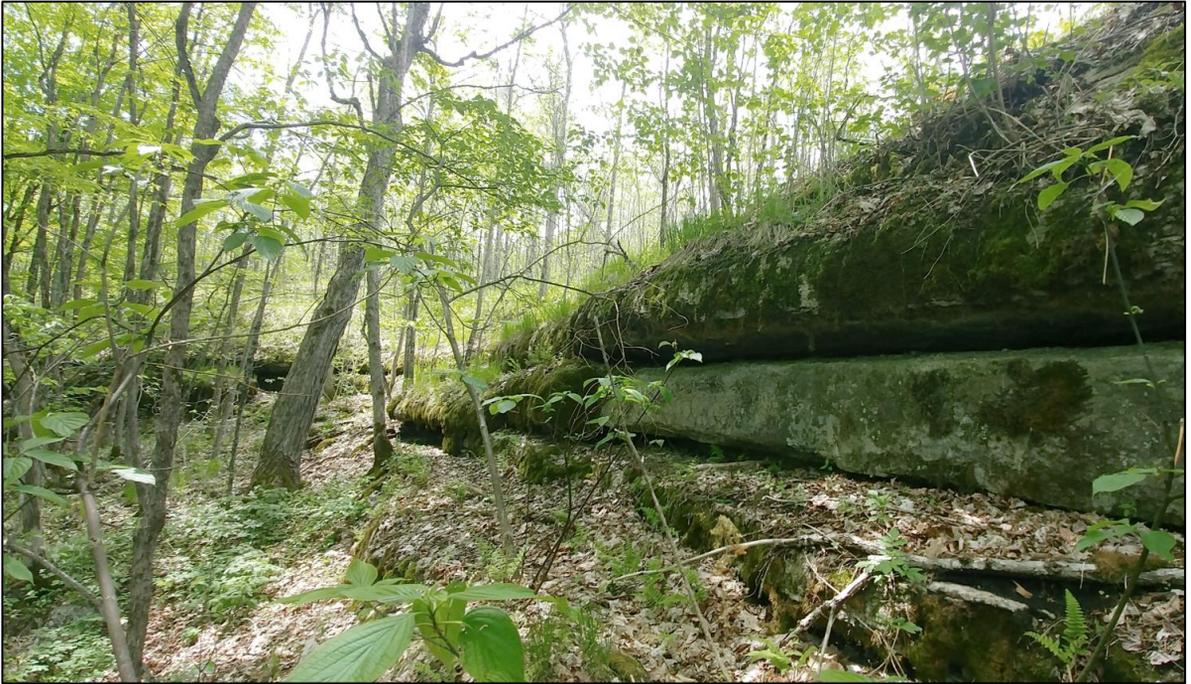
Photo 7: Exposed limestone escarpment on the north side of the west lot looking east to the cut in the escarpment with more constant slope.

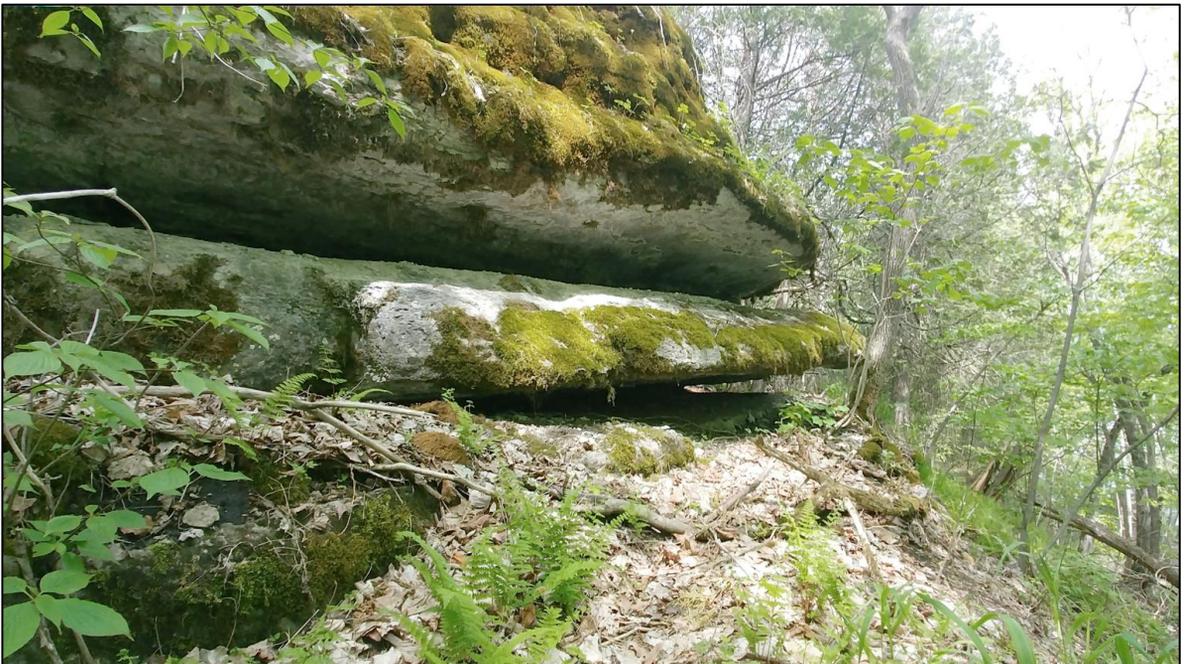
Photo 8: Up-close view of limestone with erosion between bedding planes.

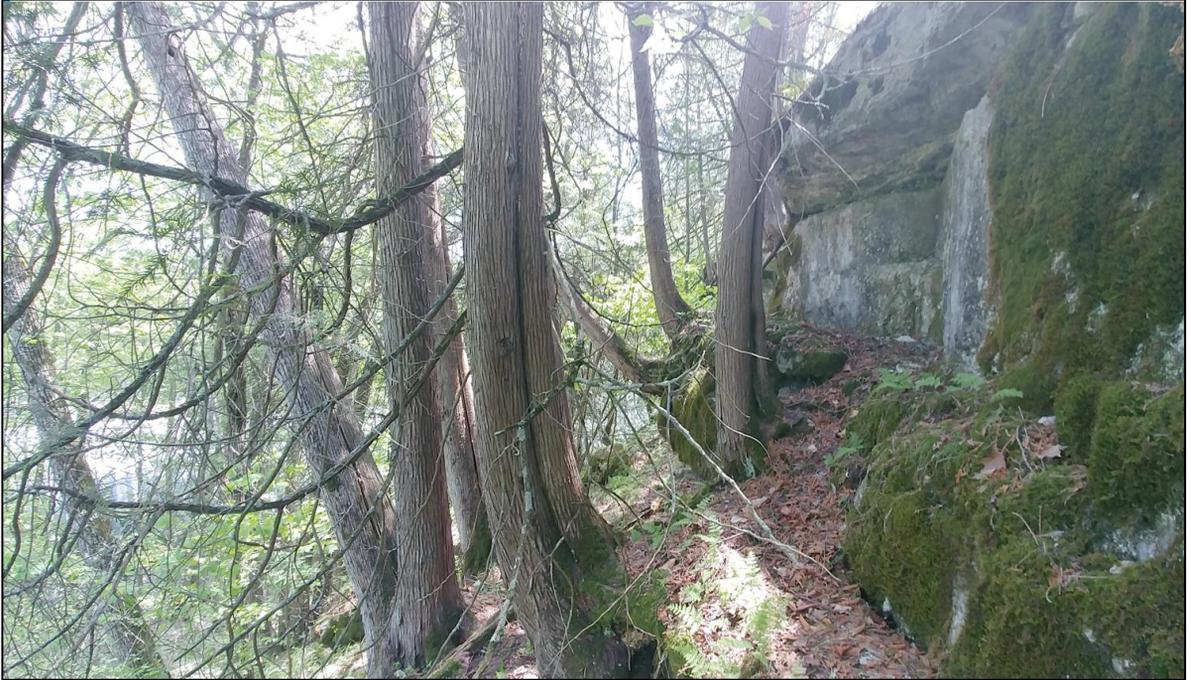
Based on the visual inspection, the presence of exposed bedrock on site, and the specific site conditions present, the slope at the site is considered to be unstable in its current condition, however the instability is related to surface spalling of rock, particularly in the near vertical sections, and there is not risk of deep seated slope failure. Many of these features can be seen in the site photos presented in Appendix B.

Photo 9: Significant vertical escarpment on the north side of the east lot. Near vertical exposed limestone of greater than 3m in height atop a steep slope. Cedar trees visible at the base of the escarpment growing at an angle to vertical.

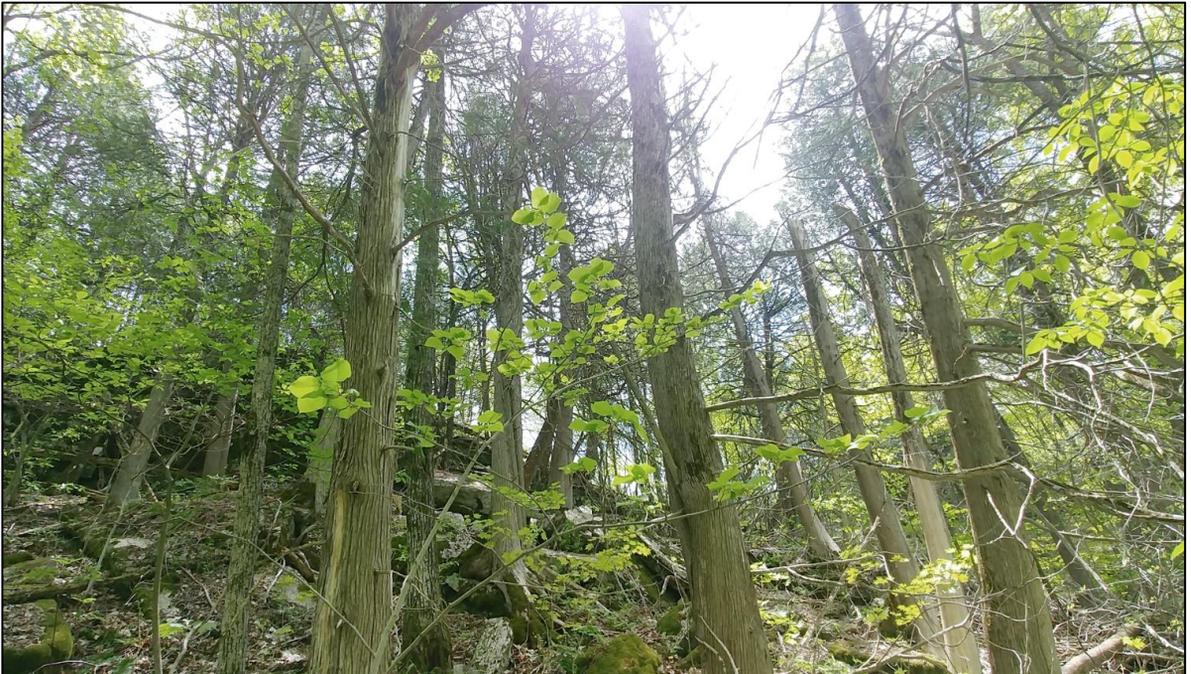
8. Previous Landslide Activity – Large limestone boulders at the base of the escarpment and smaller limestone blocks further down the slope provide evidence of previous slope failure, giving a rating of 6.

Photo 10: Small limestone blocks that have fallen/tumbled down the slope in the area of the cedar grove on the north side of the east lot.

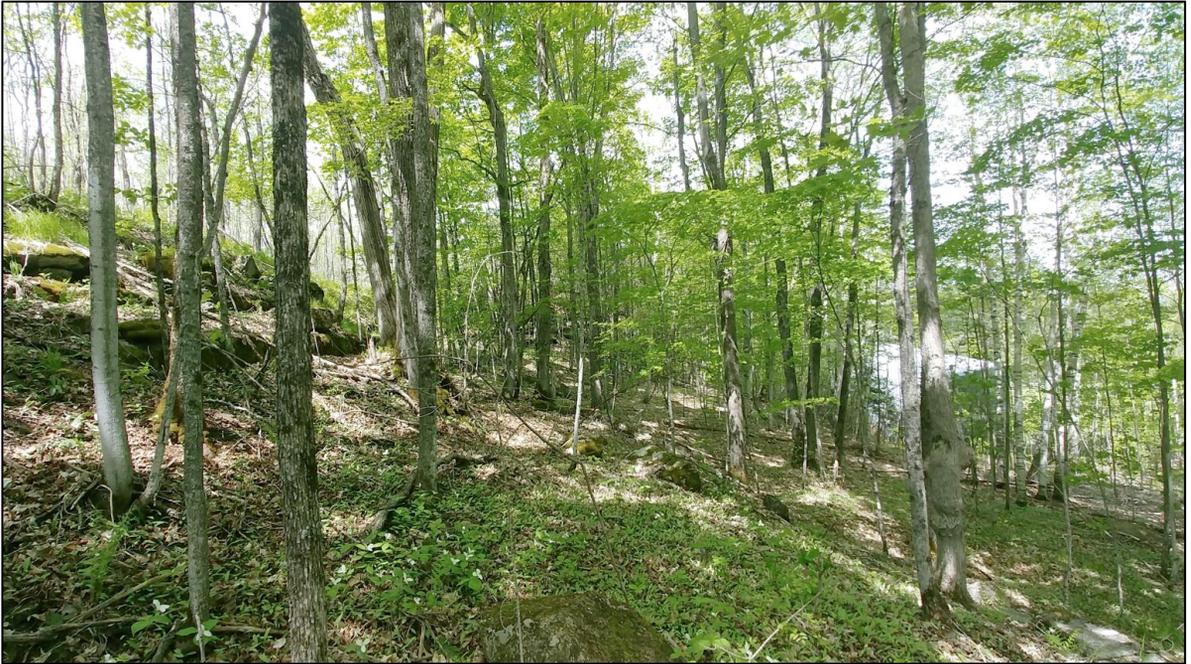
Photo 11: General greater than 3H:1V slope below the escarpment leveling out to the north (right in the photo). Exposed limestone bedrock within the 3H:1V slope and below the base of the slope.

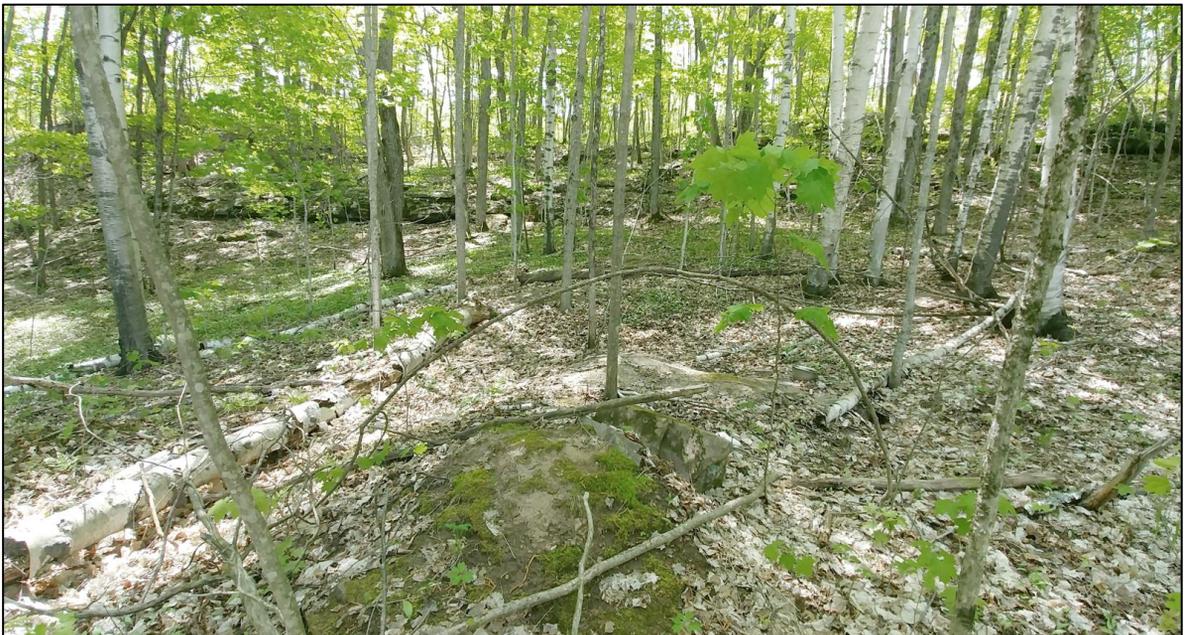
Photo 12: View of the slope and escarpment from the base of the slope, looking north.
