# Geotechnical Investigation Report

## Miles Shore Road

March 12, 2024

Cambium Reference: 19793-001

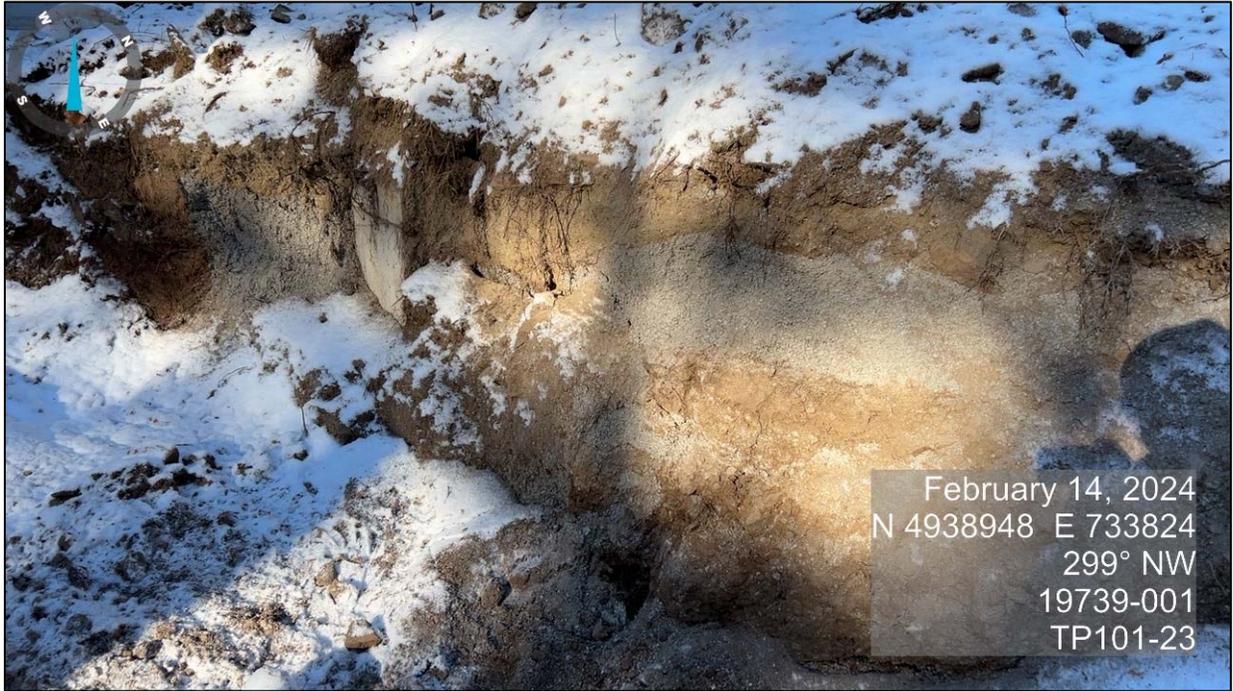
**Photo 1 TP101-24. Various layers of fill overlying Precambrian bedrock. Concrete septic tank on left side of image**

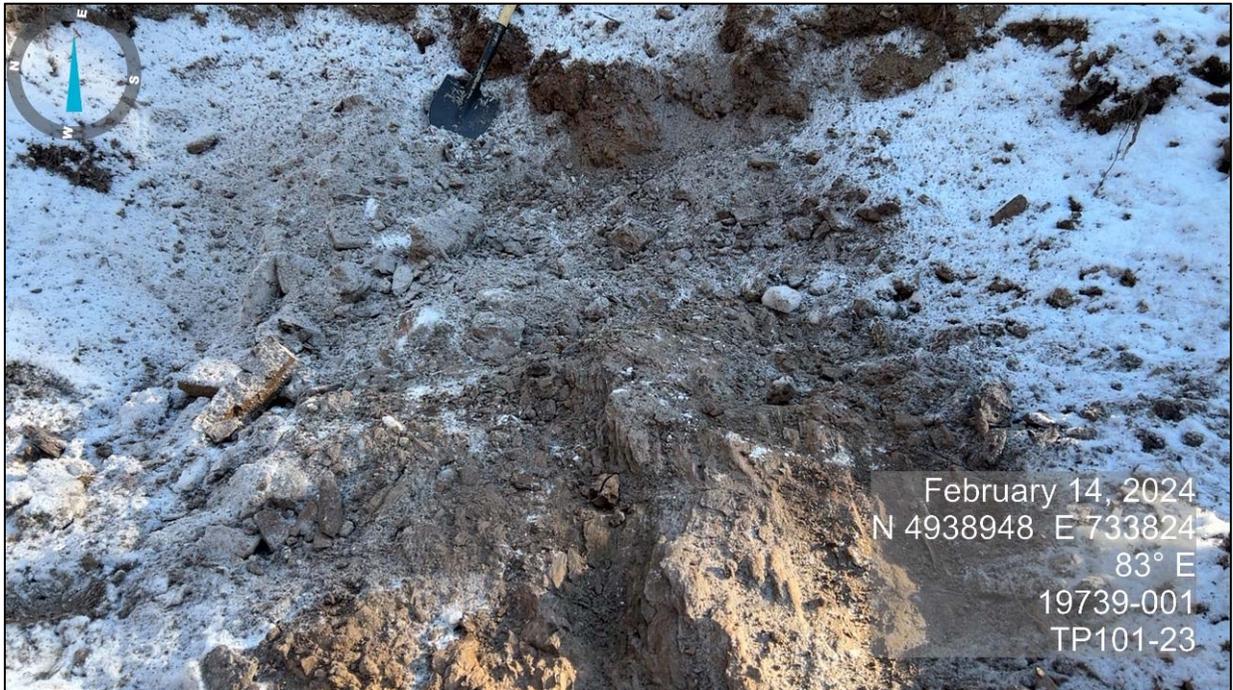
Test pits were advanced by the Client at the top of the slope on both the east and west sides of the existing residential structure. Excavations revealed 0.3 m to 1.4 m of topsoil and fill overlying metasedimentary Precambrian bedrock. Bedrock was encountered at 1.4 m below existing grade (mbeg) in TP101-24, on the east side of the existing structure. The overburden soils were mainly silty gravelly sand fill with limestone screenings used at surface for the driveway. The septic tank was visible in the northwest corner of the test pit. Bedrock was found to be mostly competent bedrock with some thin areas of fissile rock that could easily be removed by the excavator. Bedrock bedding had a strike of 89 degrees and dip of 61 degrees, providing evidence that the bedrock was dipping down into the slope, with no associated failure plane in line with the slope itself. Bedrock was encountered at 0.3 mbeg in TP102-24, on the west side of the existing structure. The overburden soils were entirely topsoil. The bedrock was found to be weathered and easily excavatable to a depth of 0.8 mbeg, where massive, competent bedrock was encountered. Bedrock bedding had a strike of 75 degrees

and dip of 61 degrees, providing evidence that the bedding planes were again perpendicular to the slope.

**Photo 2 TP102-24. Bedded Precambrian bedrock dipping to the south. Slope is to the north.**

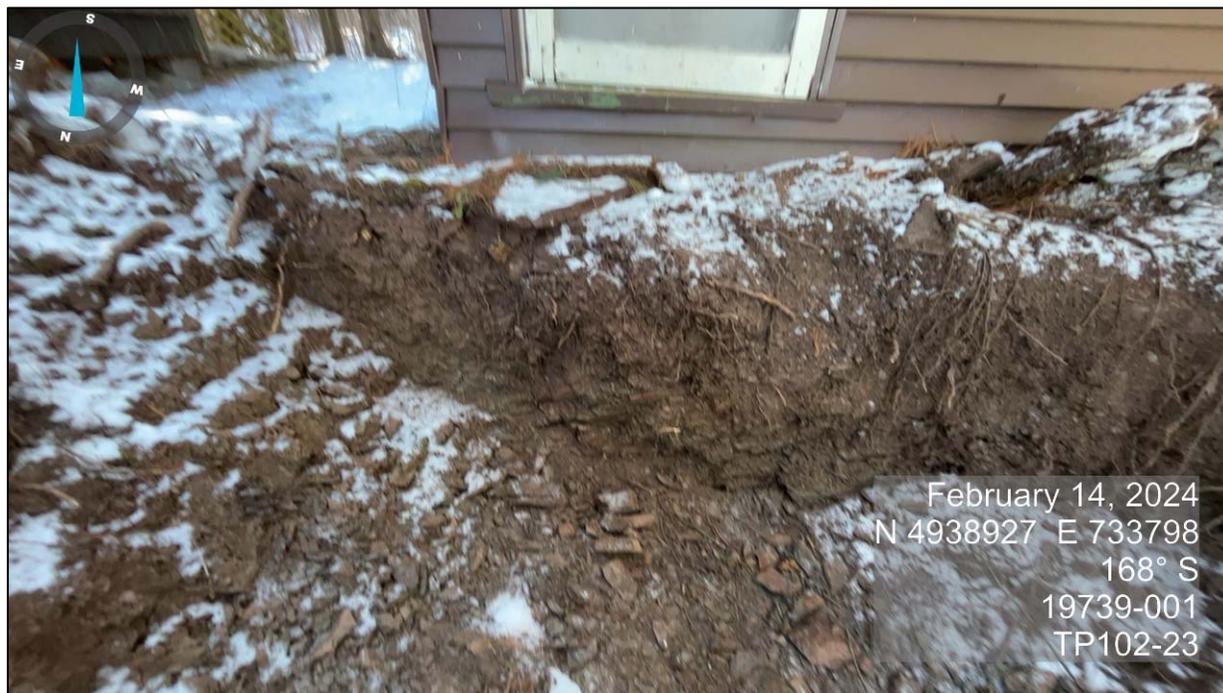
**Photo 3 TP102-24. Weathered fissile bedrock overlying competent bedrock. Weathered bedrock has been excavated and removed from test pit.**

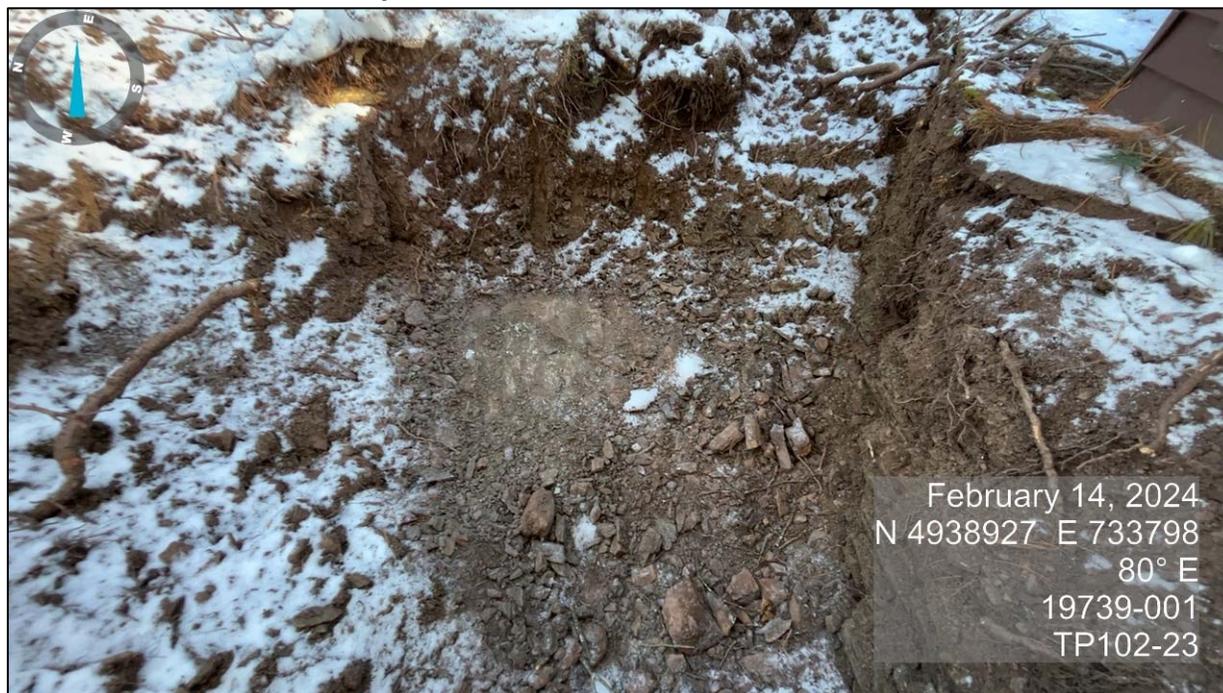
**Photo 4 TP102-24. Competent bedrock exposed at 0.80 mbgs.**

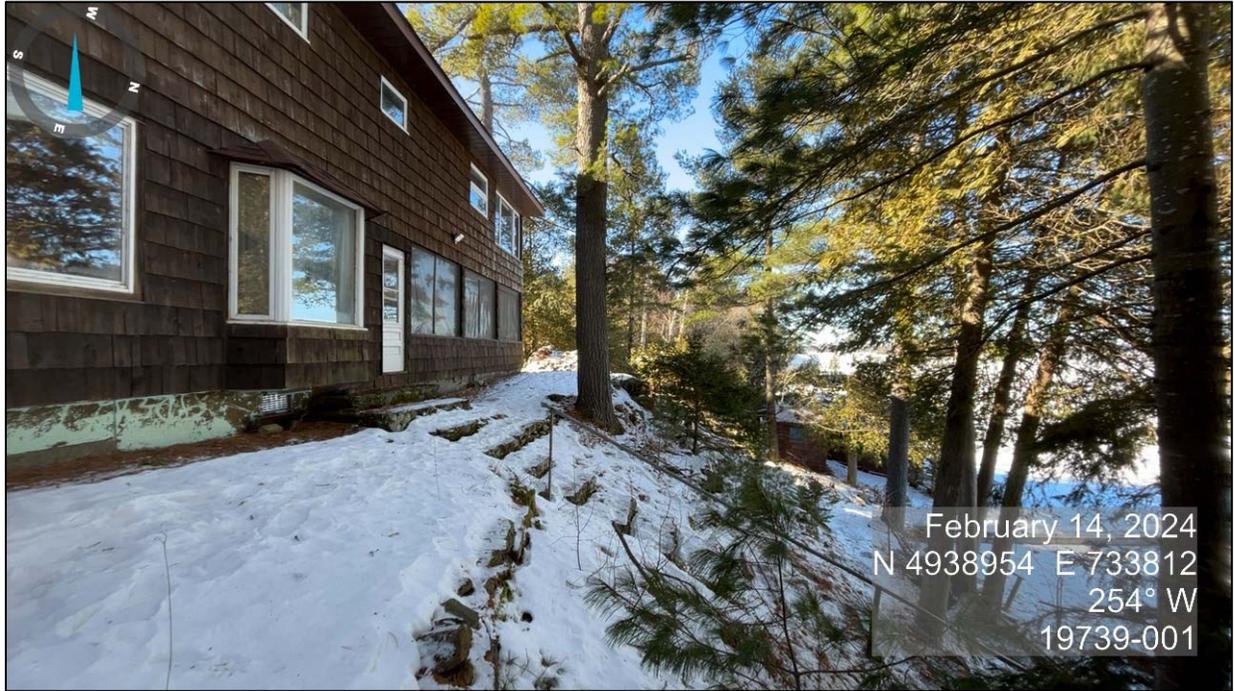
**Photo 5** Top of slope and slope face along the north side of the house.

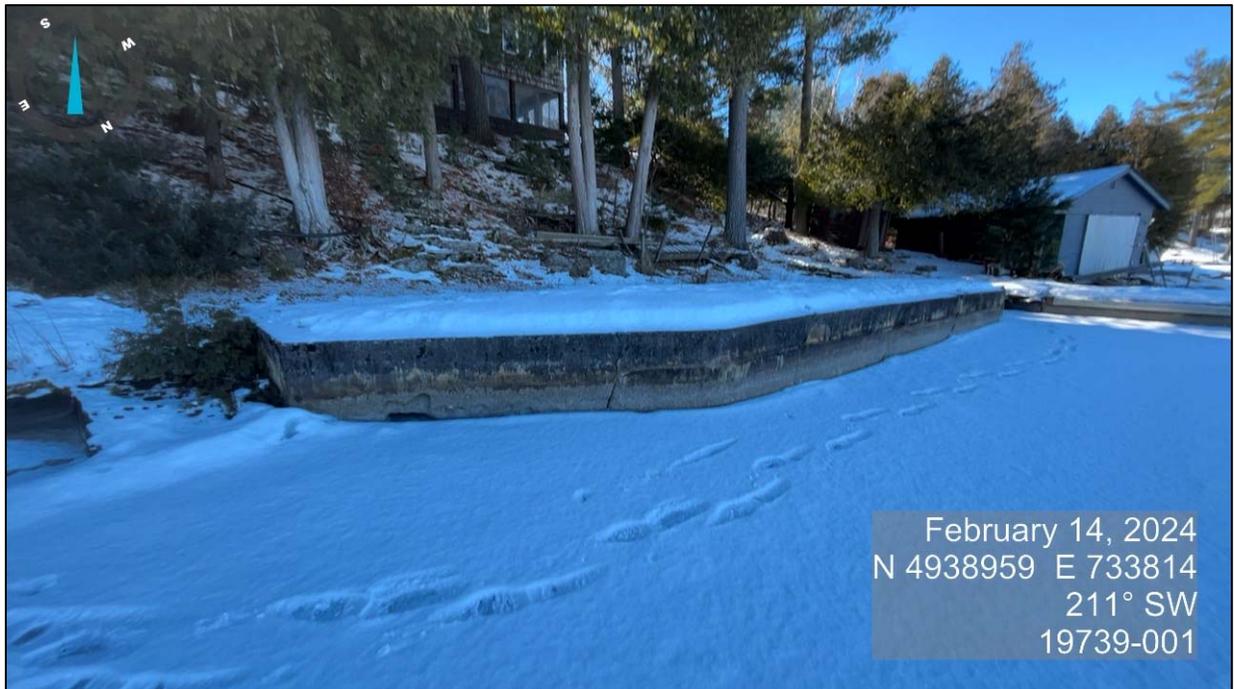
**Photo 6** Concrete pier at the toe of the slope. Pier extends down to lake level.

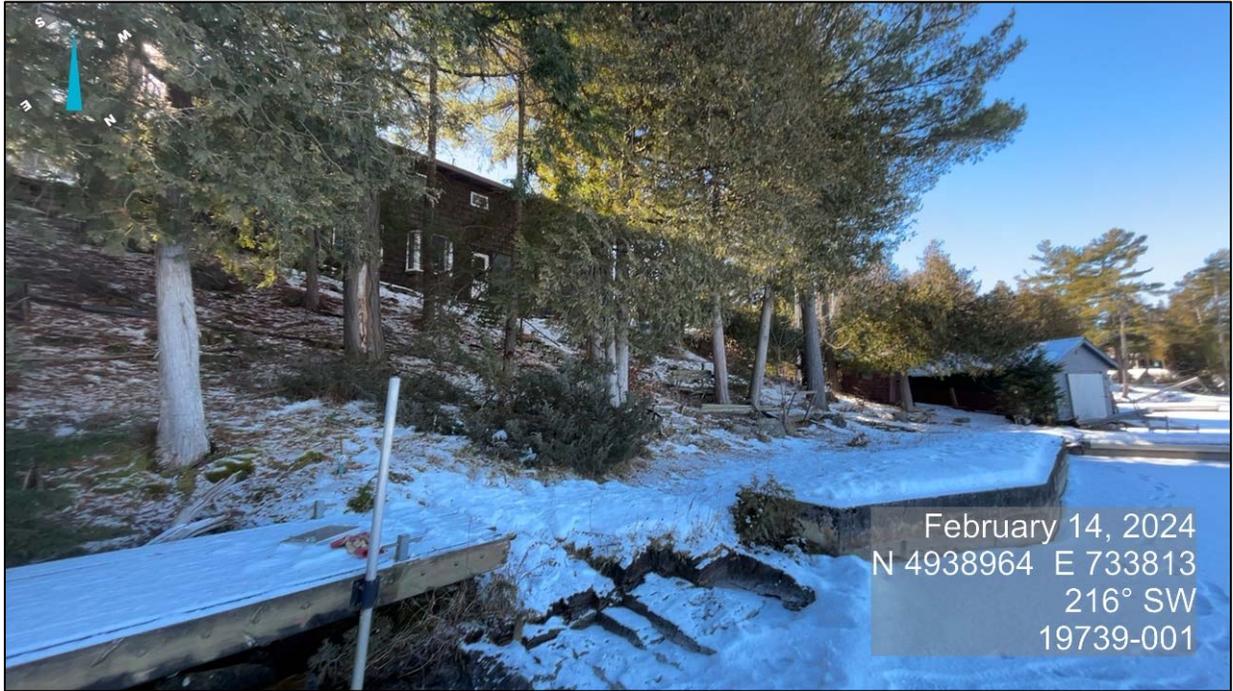
**Photo 7** Exposed bedrock between wooden decking and concrete pier at toe of slope.

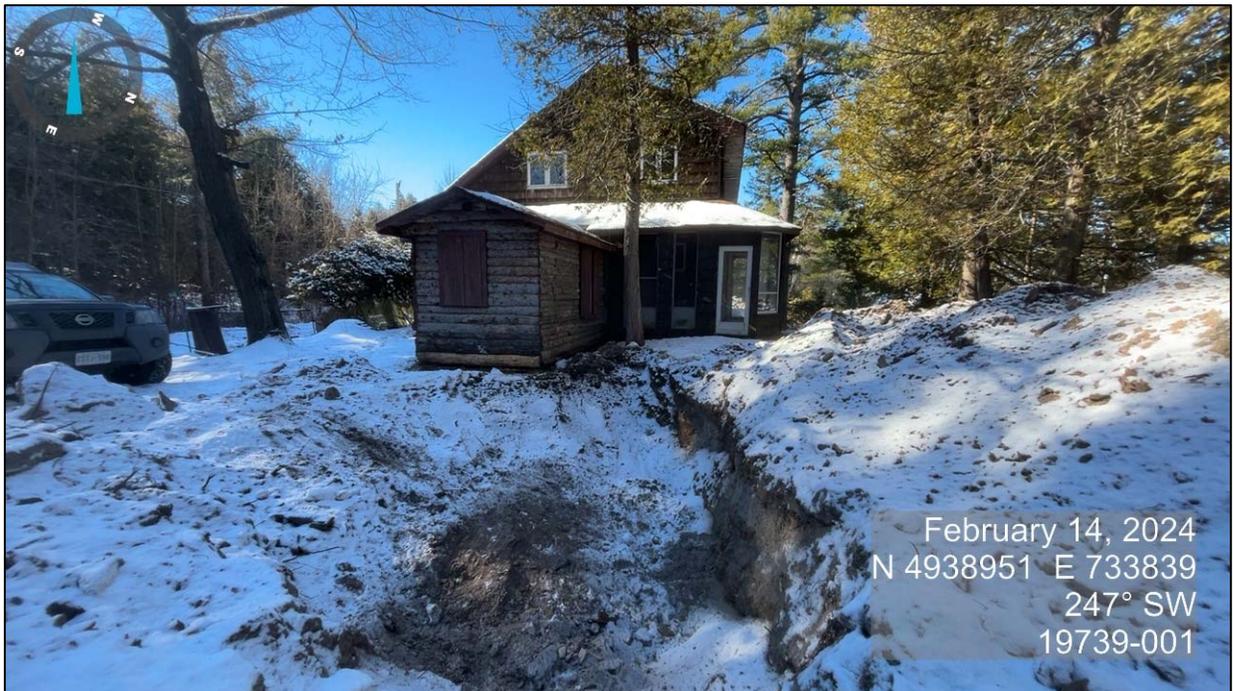
**Photo 8** TP101-24. Table land above slope was excavated to expose bedrock for investigation.

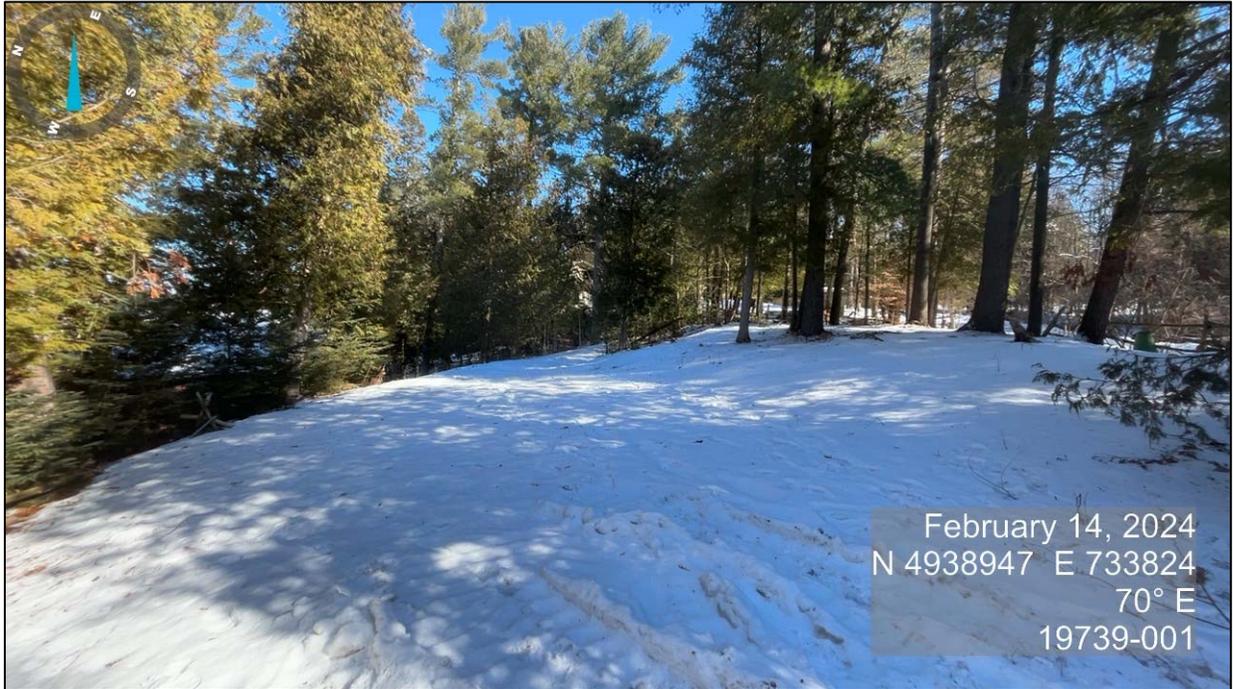
**Photo 9** Table land above boathouse. The flat, bare snow covered area is a gravel driveway. Slope is to the north.

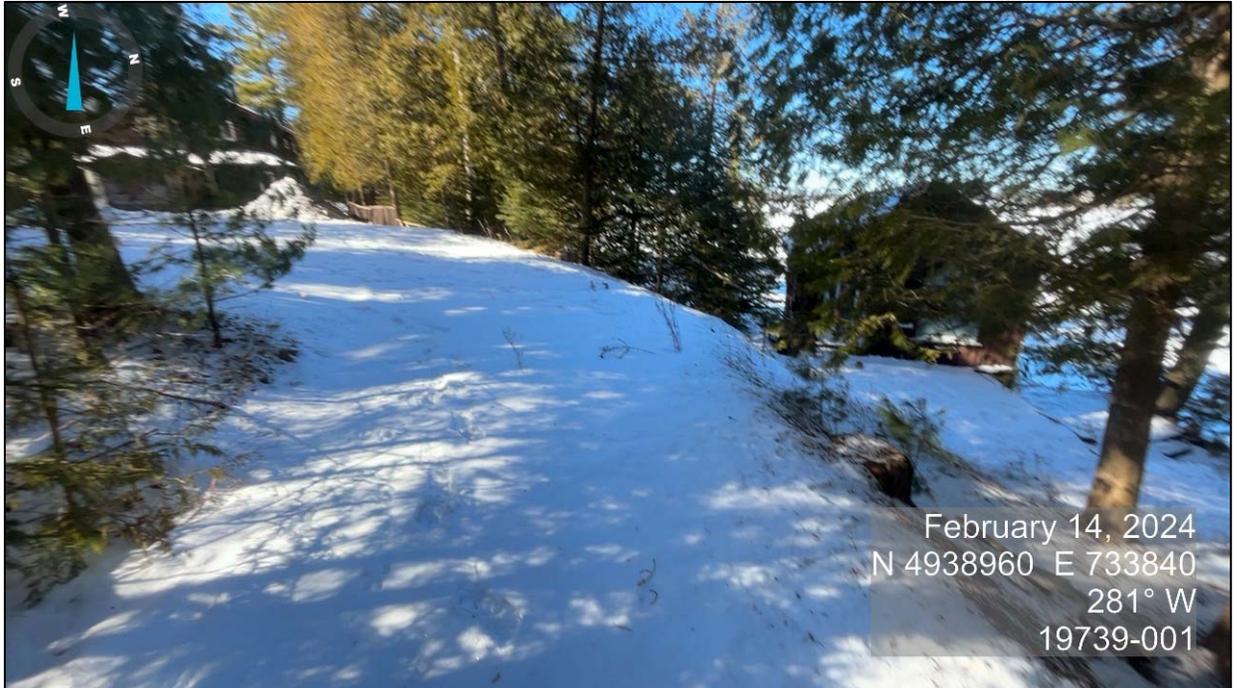
**Photo 10** Top of slope/edge of driveway, boathouse structure visible in left side of image at the slope bottom.

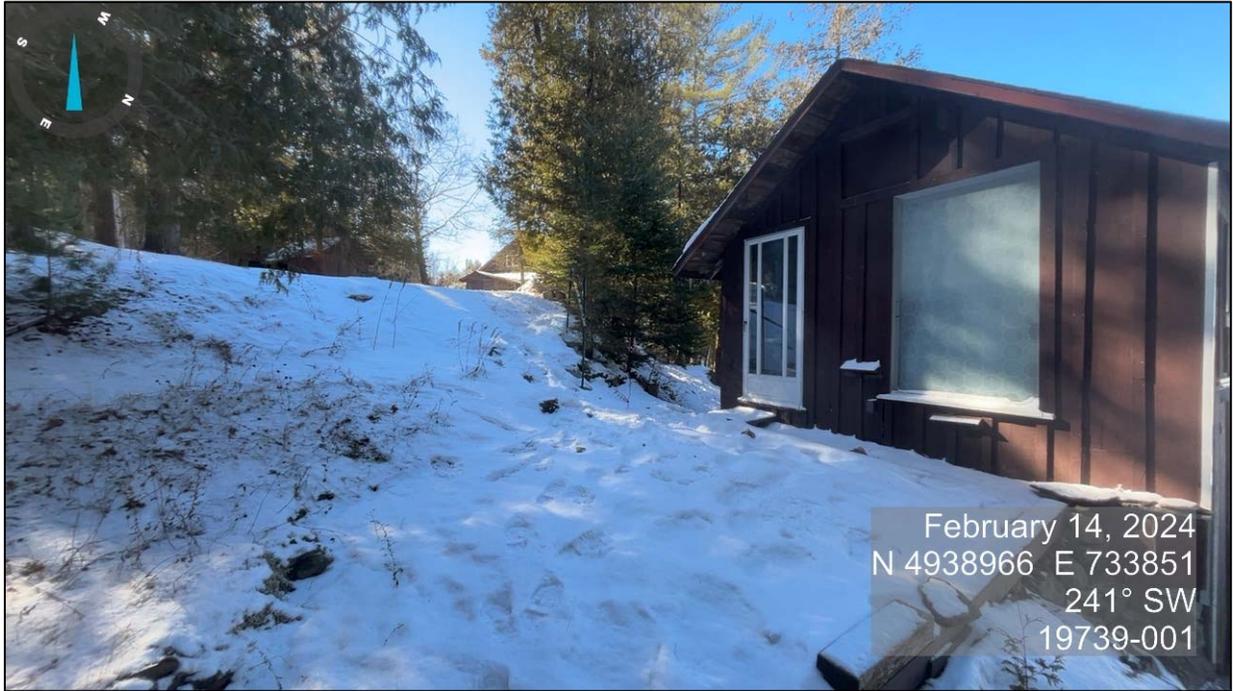
**Photo 11 Slope face at eastern edge of boathouse. Flattened snow covered area at entrance consists of decking.**

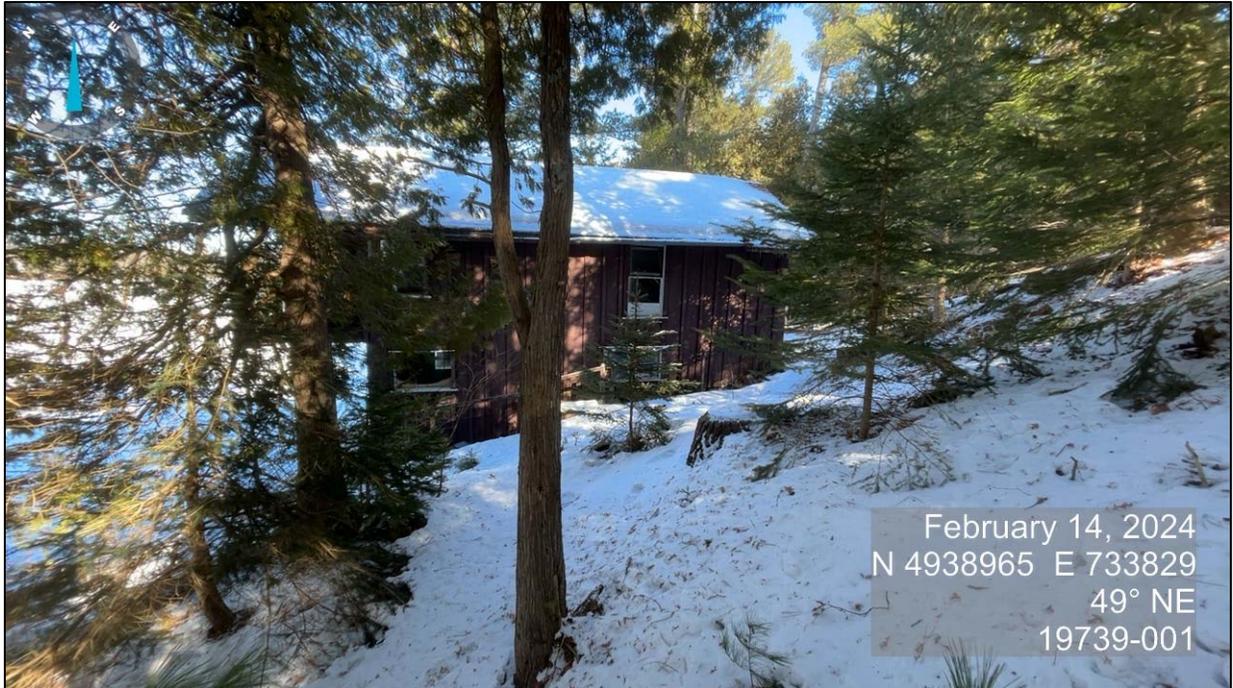
**Photo 12 Slope face at western edge of boathouse.**

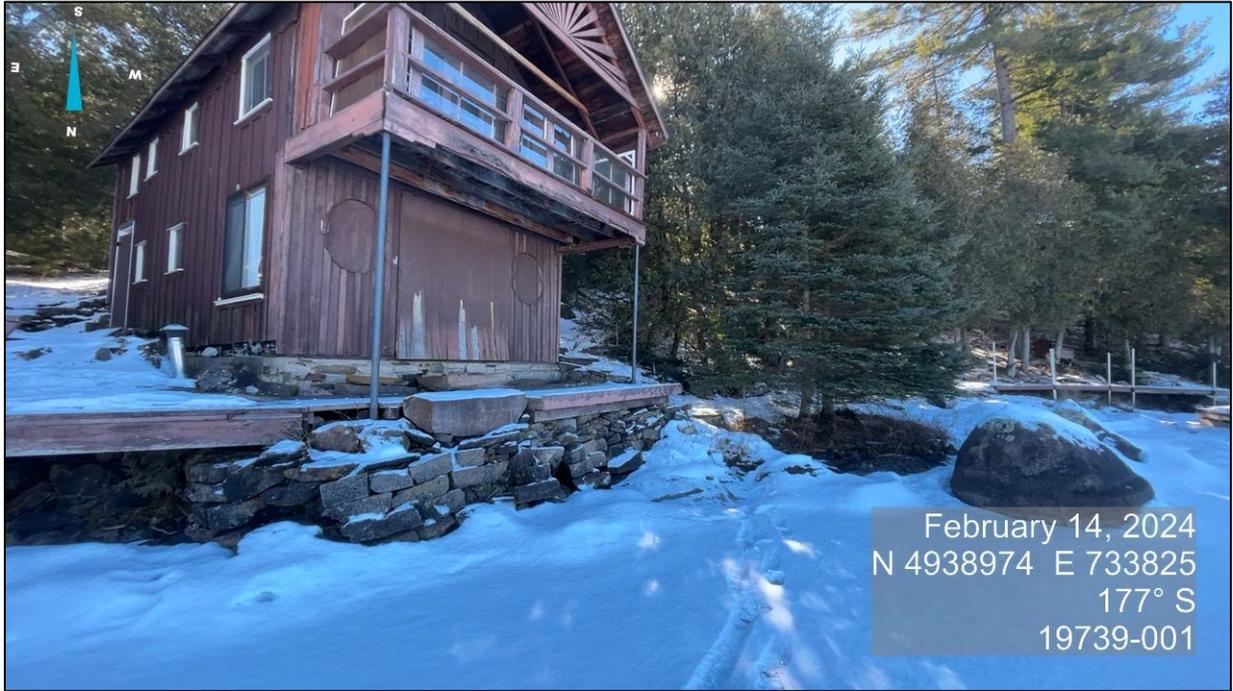
**Photo 13** Shoreline at the bottom of the slope in front of boathouse.

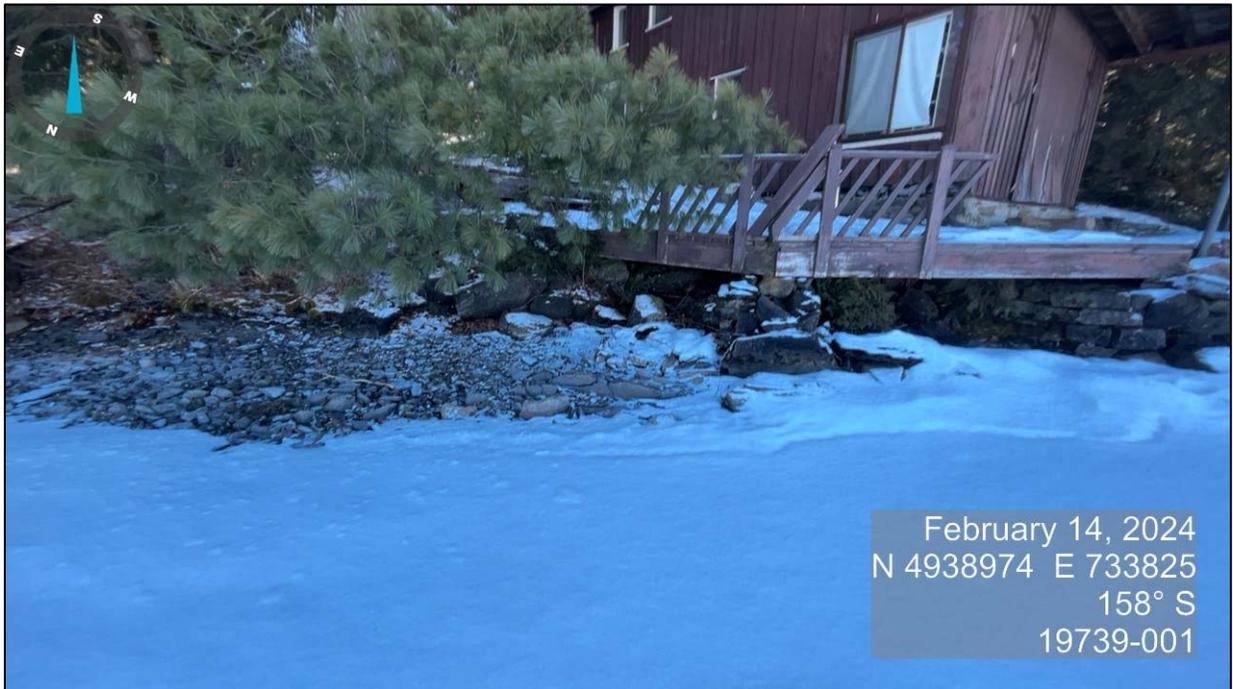
**Photo 14** Boathouse shoreline with gravel overlying shallow bedrock.

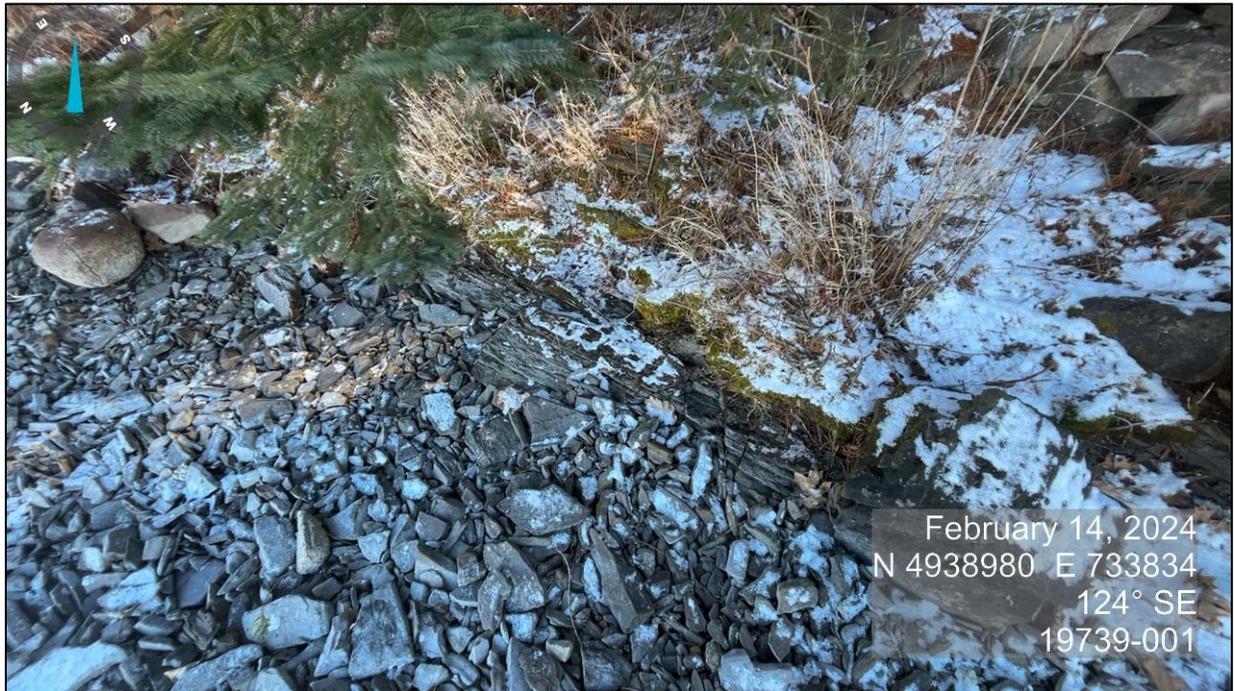
***Photo 15 Exposed bedding in bedrock on boathouse shoreline.***
