Geotechnical Investigation & Slope Stability Study - Lot 3 Indacom Drive, Douro- Dummer

2021-10-22

Prepared for:
The Township of Douro-Dummer

© Cambium 2019 Reference No.: 13455-001

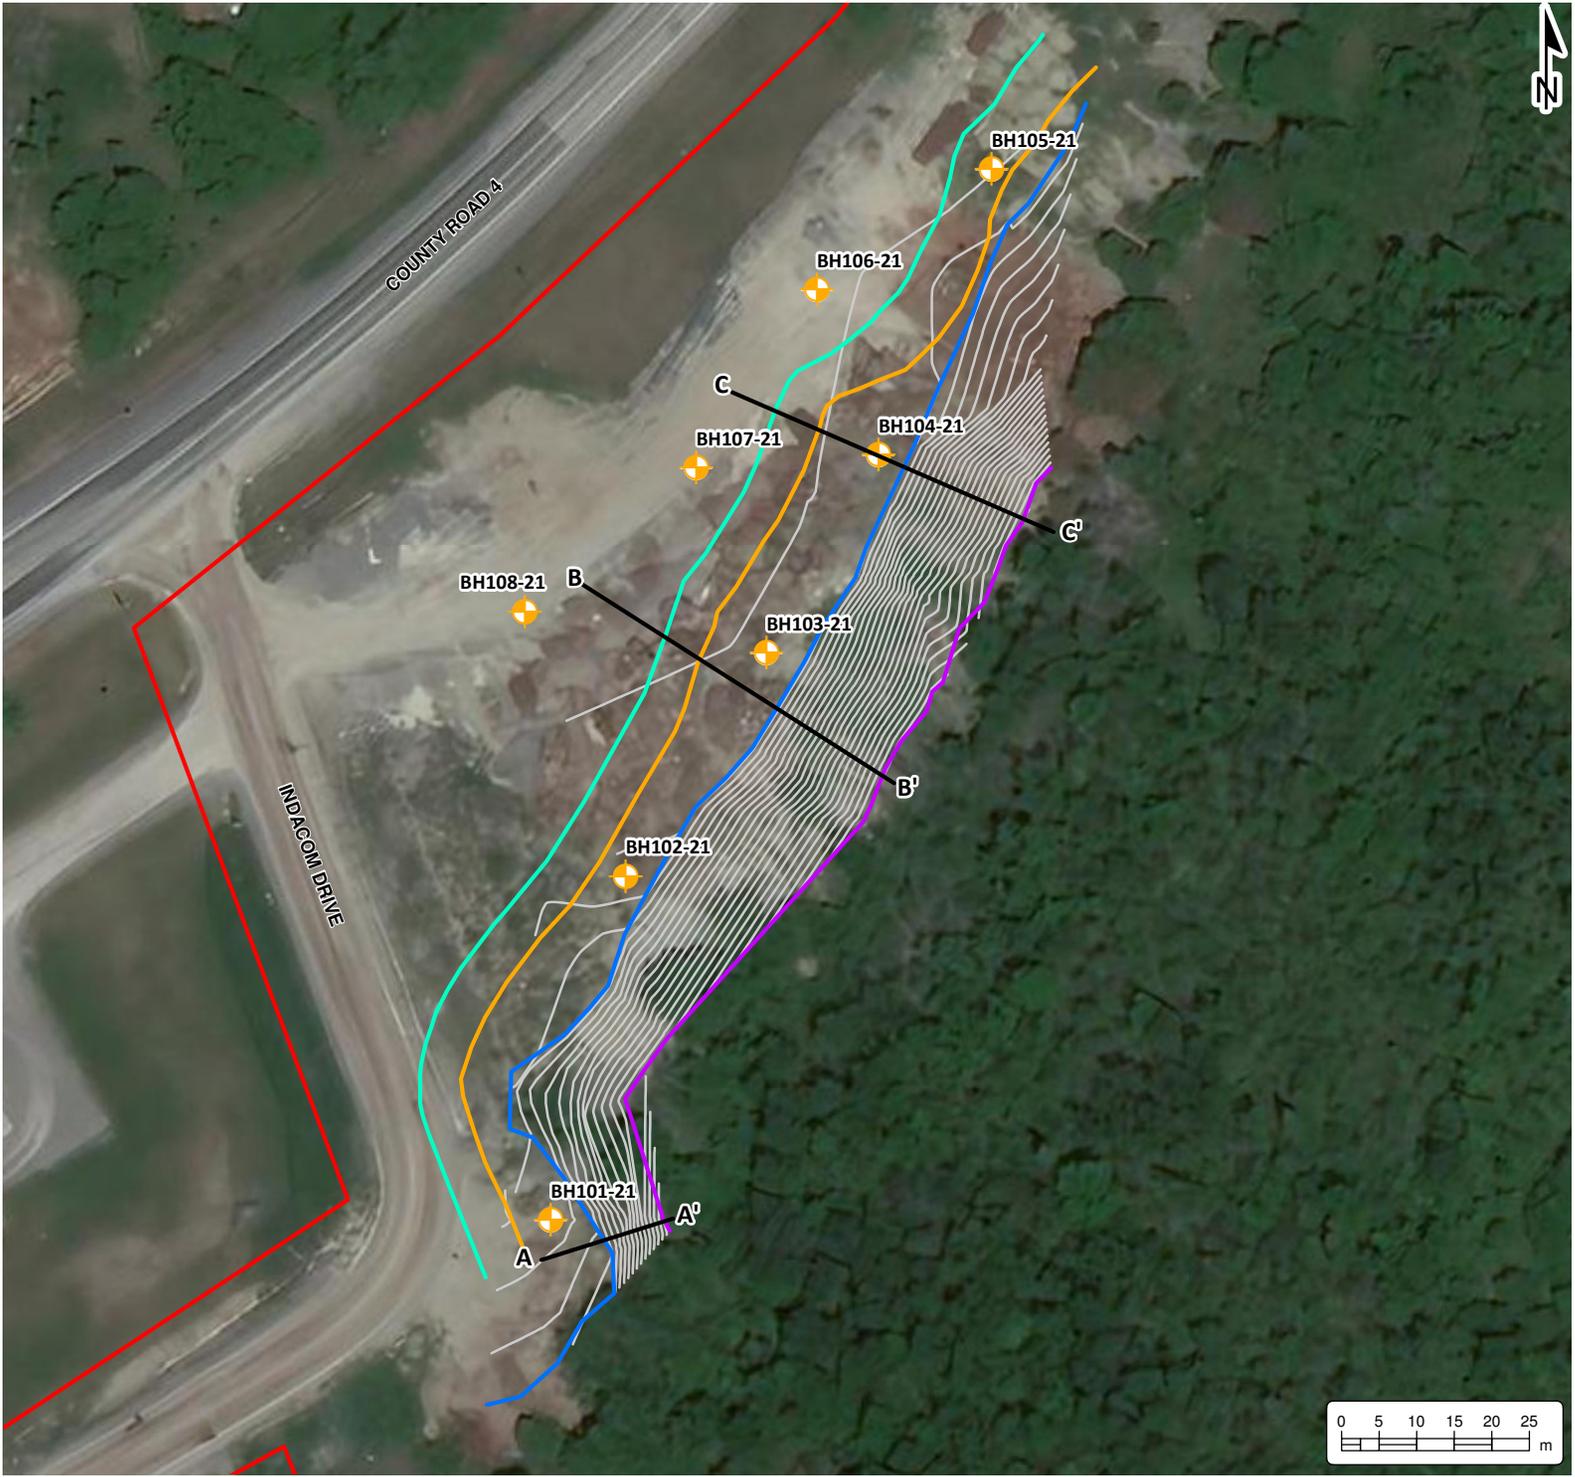
Figure 1	Borehole Location Plan and Erosion Hazard Limits
----------	--

The erosion hazard limit is illustrated in Figure 1 as a 6 m setback from the top of stable slope, which ranges from 25 m to 36 m horizontally from the base of the slope.

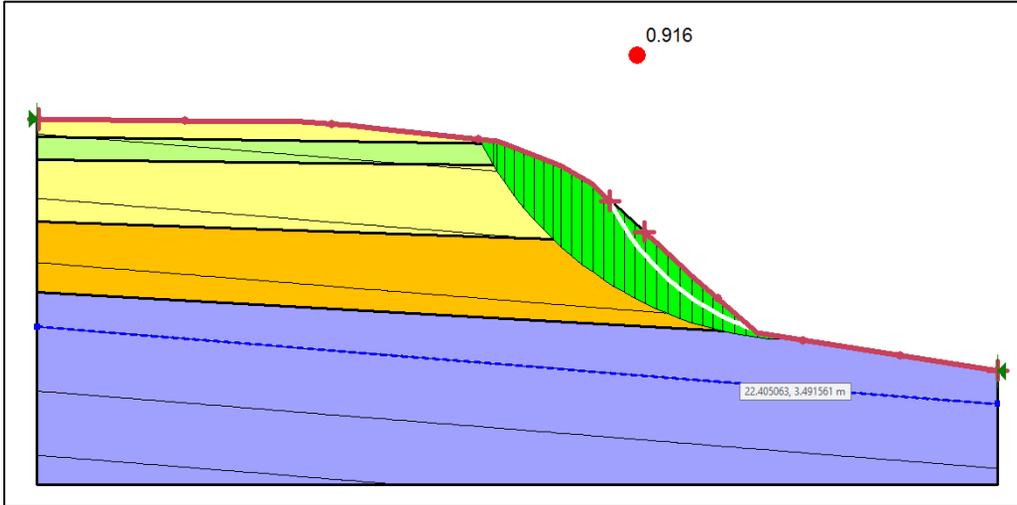
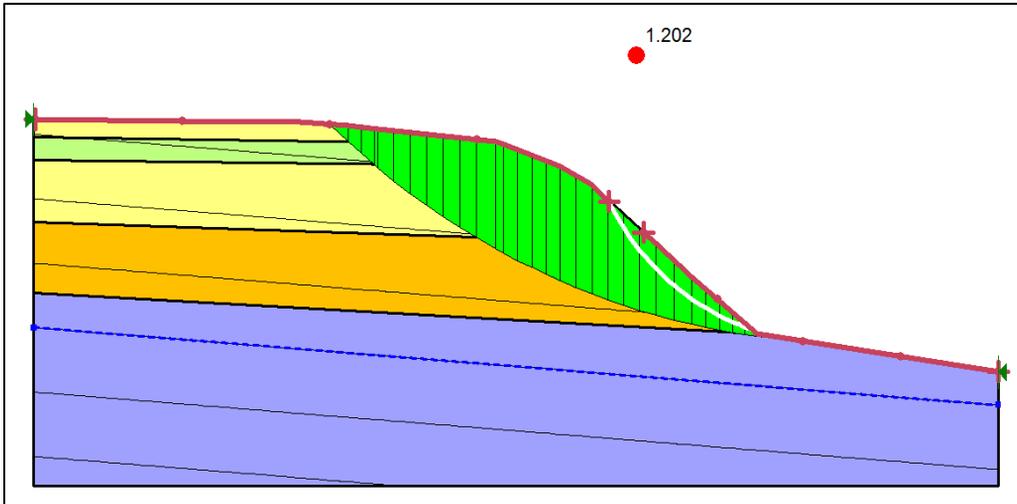
Section A-A' Existing Conditions (1H:1V)

Based on engineering analysis it was clear that the existing slopes are unstable in their current state, however reshaped 2.7H:1V slopes provide a FOS of 1.5 and are considered stable, even under loads of the proposed structures, provided they are keyed in to at least 1.2 mbeg or founded at greater depths.

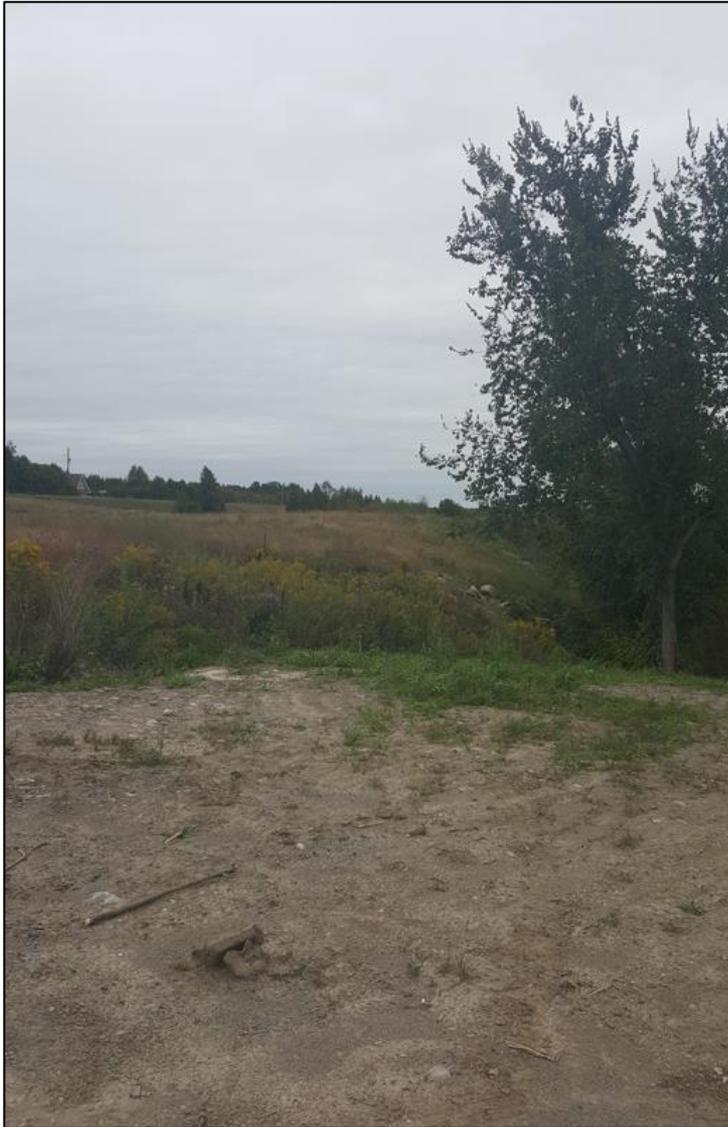
Photo 1: View of slope looking northeast from the location of BH101-21 at corner of Indacom Drive.

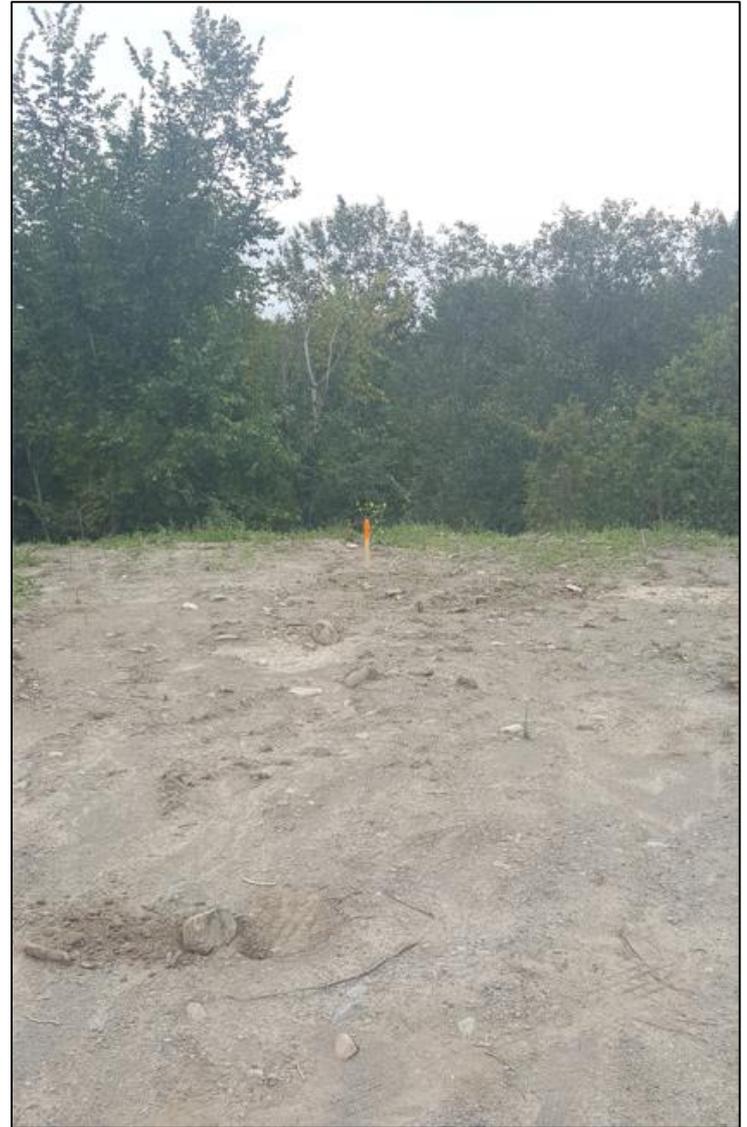
Photo 2: Location of BH101-21 on flat ground above slope.

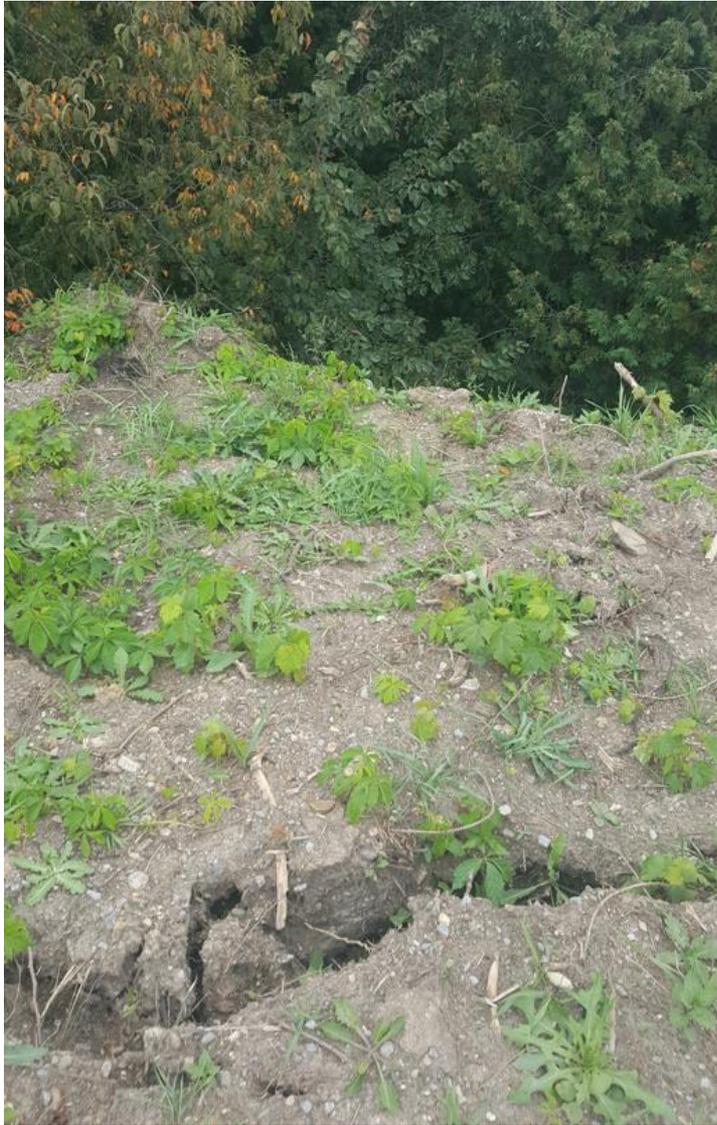
Photo 3: View of slope looking northeast from the location of BH101-21 at corner of Indacom Drive.

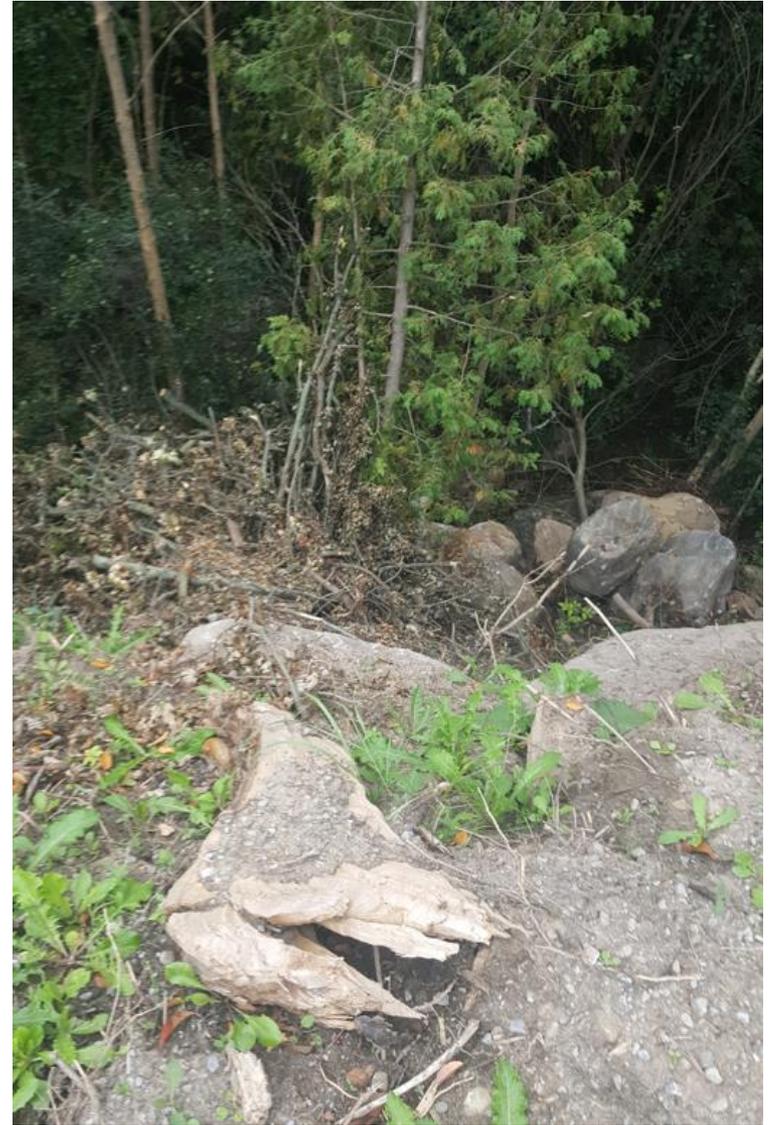
The slope adjacent to borehole BH101-21, at the bend in Indacom Drive, is characterized by a 6 m to 7 m high slope with inclination steeper than one horizontal to one vertical (1H:1V) in places. The slope along the east side of the lot is approximately 10 m to 11 m in height with an average inclination of 1.5H:1V, with some areas slightly steeper than this. There was no apparent watercourse within 15 m of the base of the slope. A large recent full slope failure exists on the northeast end of the slope and many rills and small cullies are evident within the mainly bare slope face. Many of these features are evident in the cross sections presented in Appendix D and site photographs in Appendix E.

Photo 4: View down very steep slope adjacent to BH101-21. Large rocks and organics in and on slope.

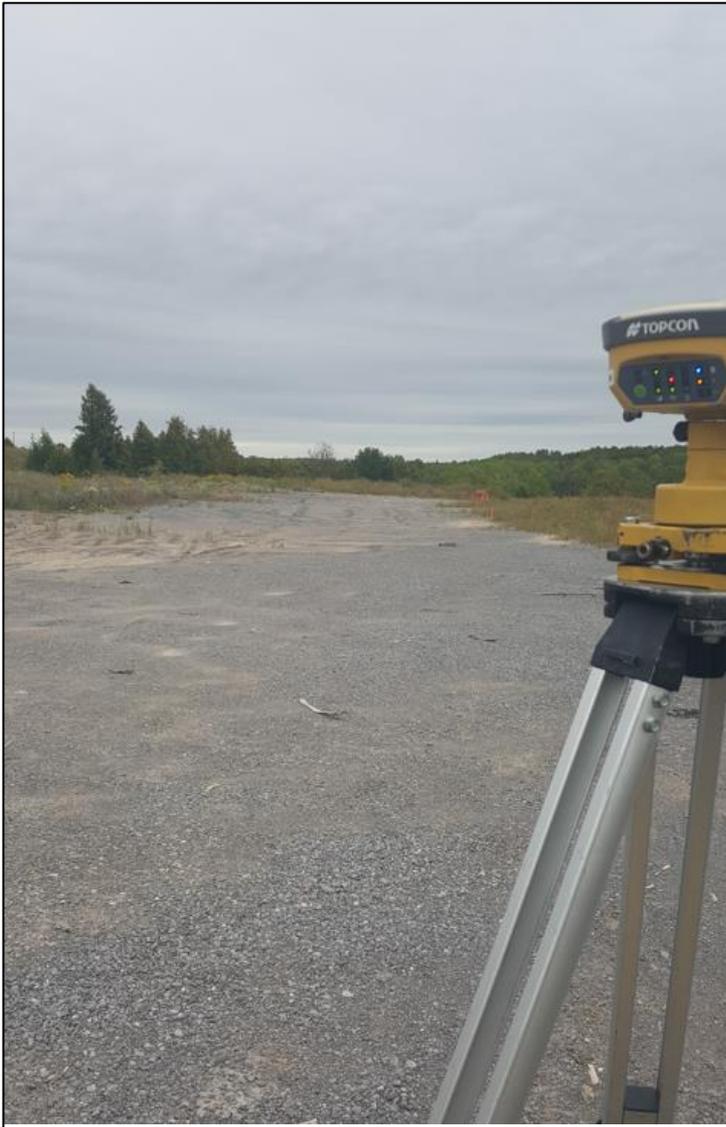
Photo 5: View of table flat land that makes up the lot atop the slope, looking east from near the entrance from Indacom Drive. Slope is to the right.

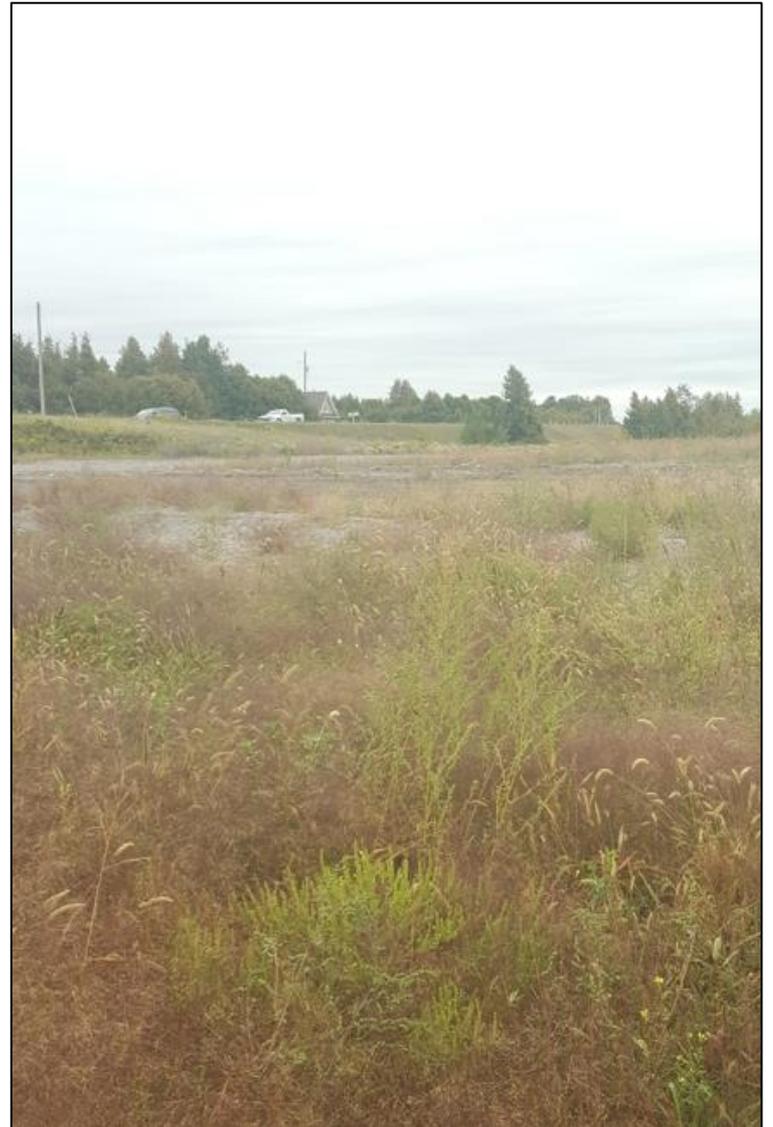
Photo 6: View looking northeast from BH102-21 across table flat land.

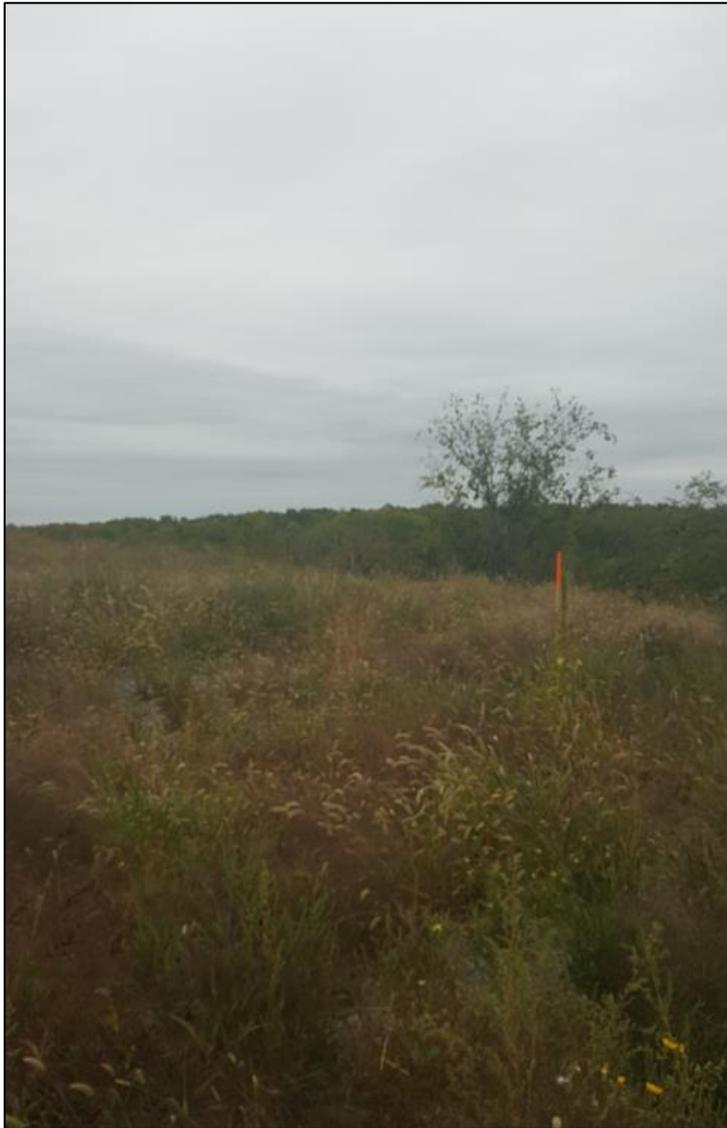
Photo 7: BH105-21 overlooking slope to SE. Long grasses at top of slope.

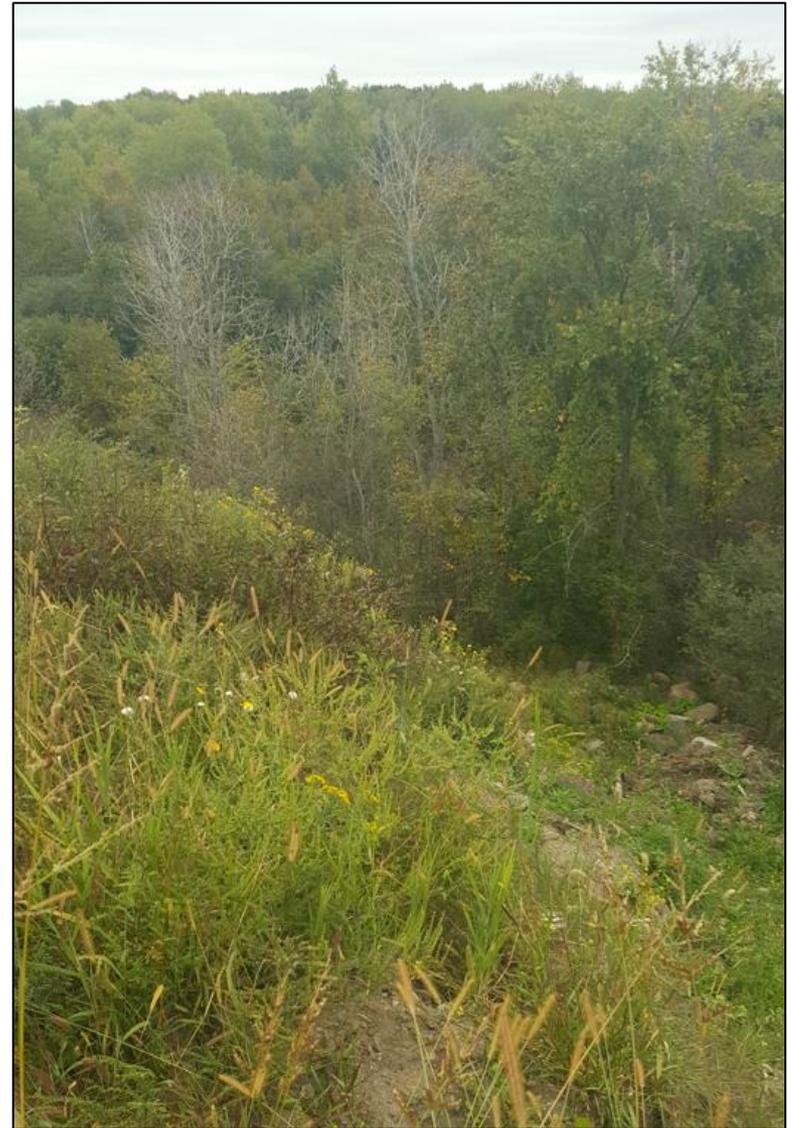
Photo 8: View looking down slope on SE side of lot. Some weeds on slope, some bare areas, large boulders at the base. Densely treed at base of slope.

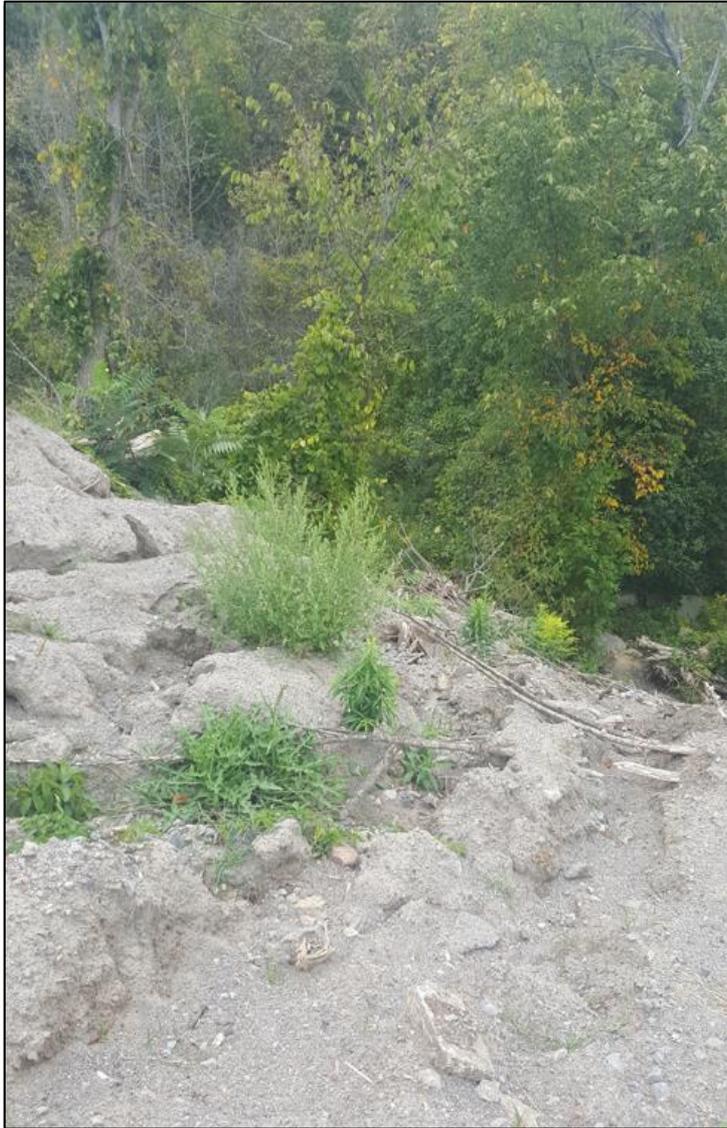
Photo 9: View of slope on SE side of lot from base of slope. Many bare areas, large boulders and large wood debris over slope.

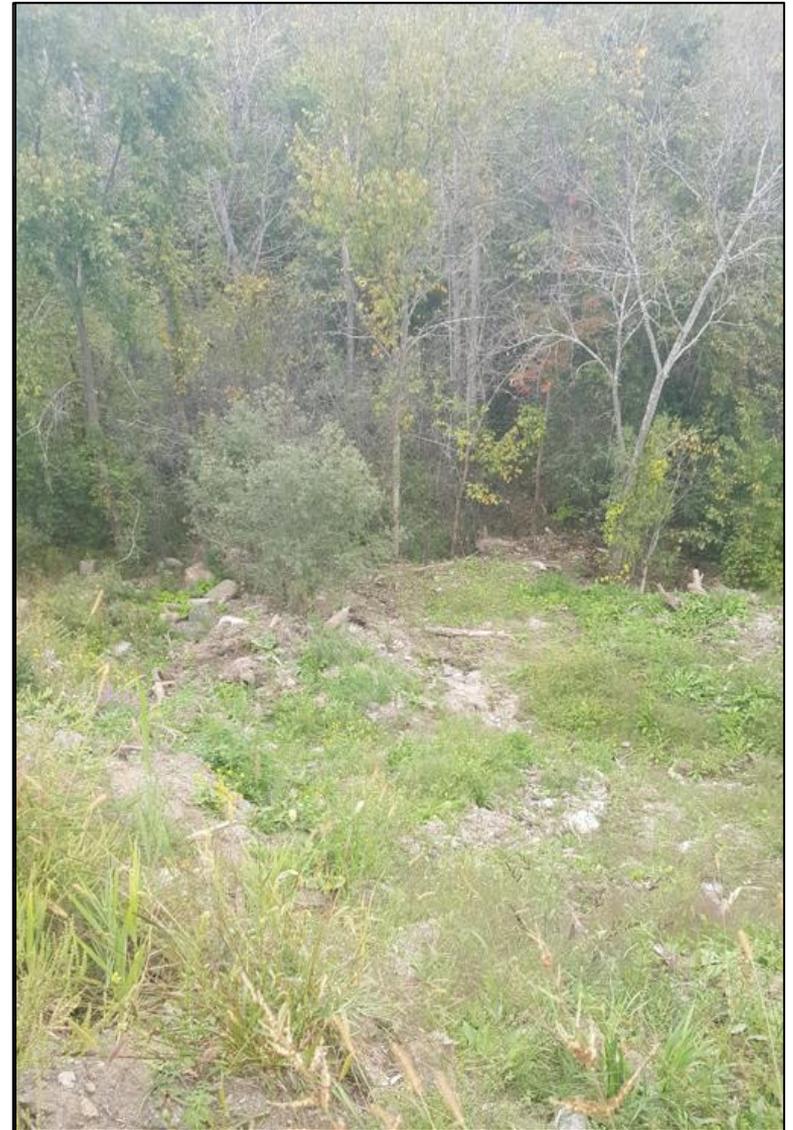
Photo 10: View looking down slope on SE side of lot. Some weeds on slope, some bare areas, large wood debris in slope. Densely treed at base of slope.

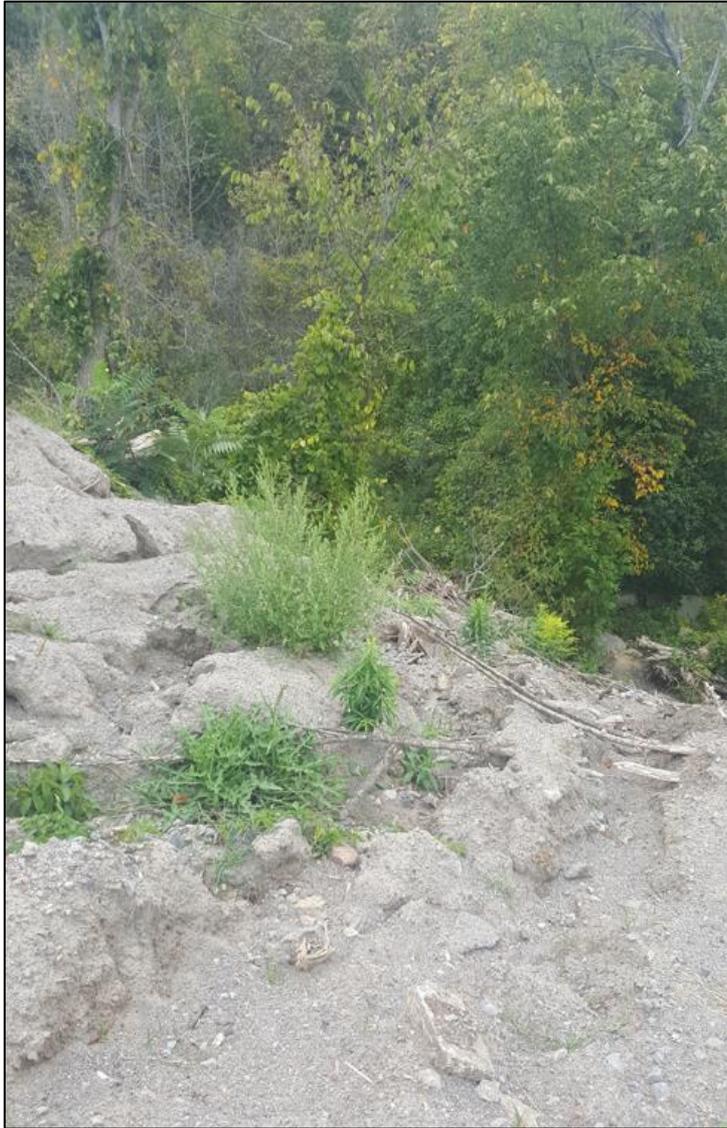
Photo 11: View of bare soil at the top of the slope where rills have formed in the soil as water drains over the slope to the SW, near BH102-21.

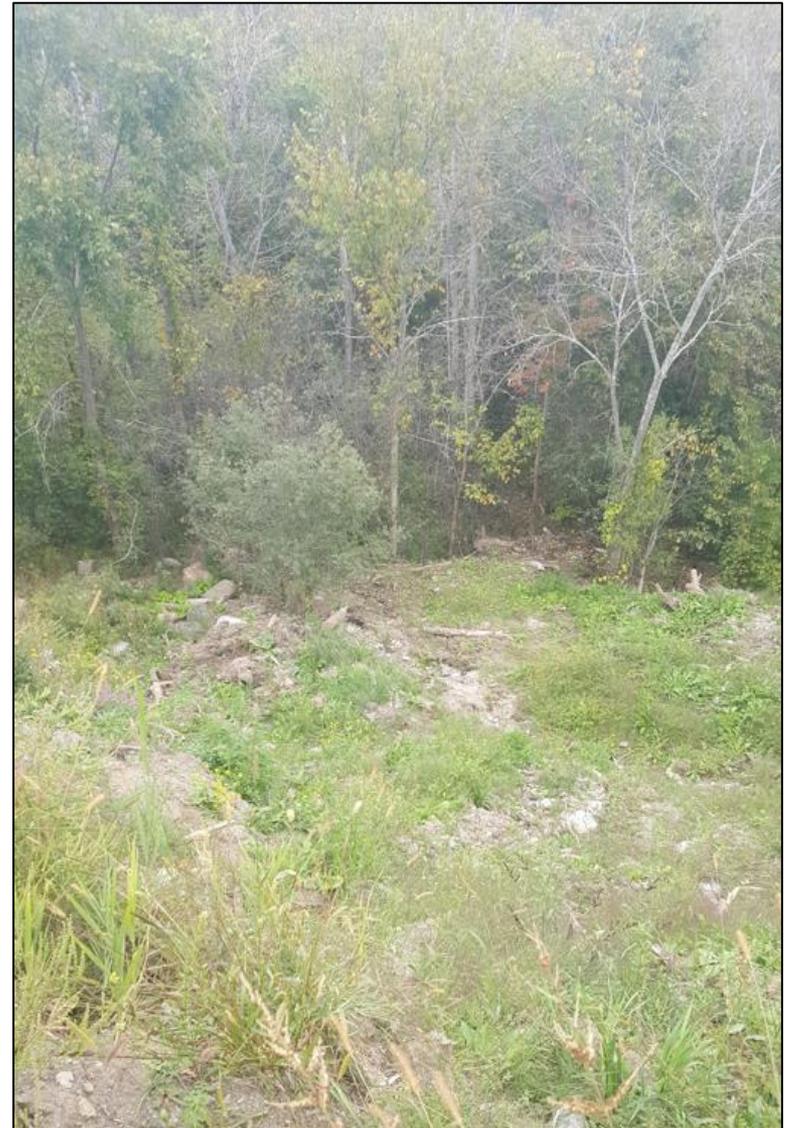
5. Vegetation Cover on Slope Face – The slope was relatively bare in general, giving a rating of 8.
6. Table Land Drainage – The table land was relatively flat, with very minor drainage over the slope to the east, giving a rating of 2.
7. Proximity of Watercourse to Slope Toe – No apparent watercourse was present within 15 m of the base of the slope, and therefore the site carries a rating of 0.
8. Previous Landslide Activity – A recent, large, full-slope failure was present on the NE end of the slope, giving a rating of 6.

Photo 12: View looking down slope between BH104-21 and BH105-21, where a landslide occurred within the slope. This portion of the slope is now less steep, after failure.

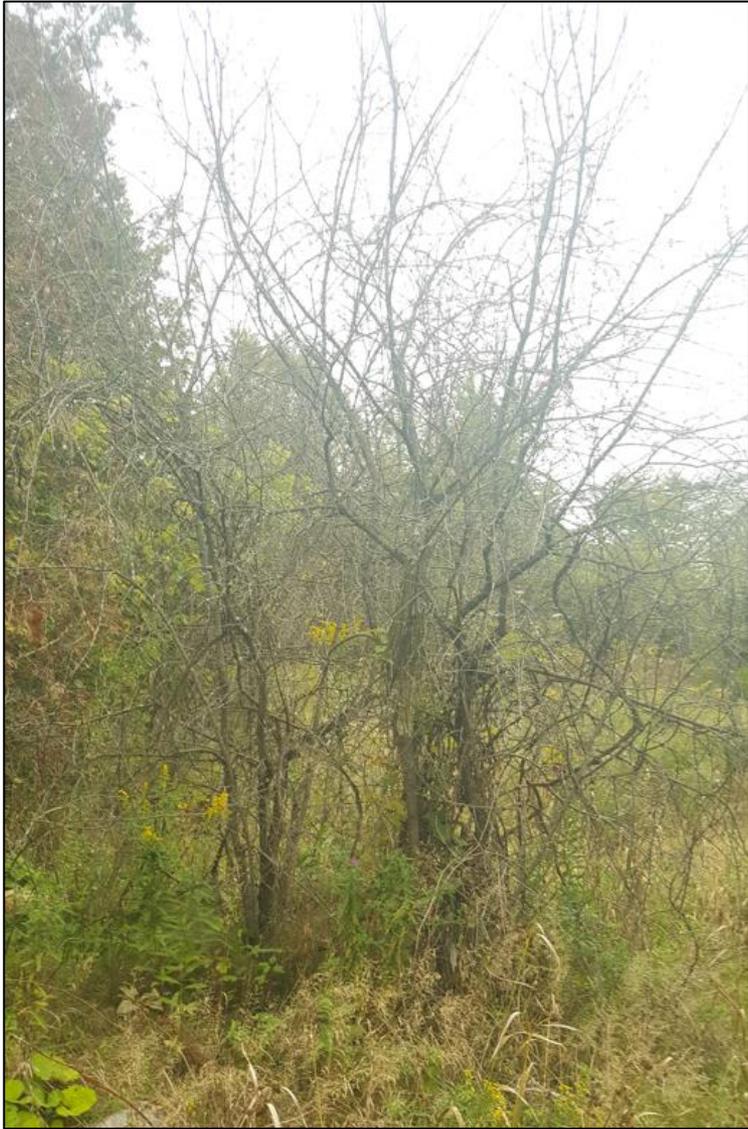
Photo 13: Relatively Flat land at the base of the slope.
