June 3, 2021

Re: Slope Stability Assessment – 912 Birchview Rd, Lakefield
Cambium Reference No: 12708-002

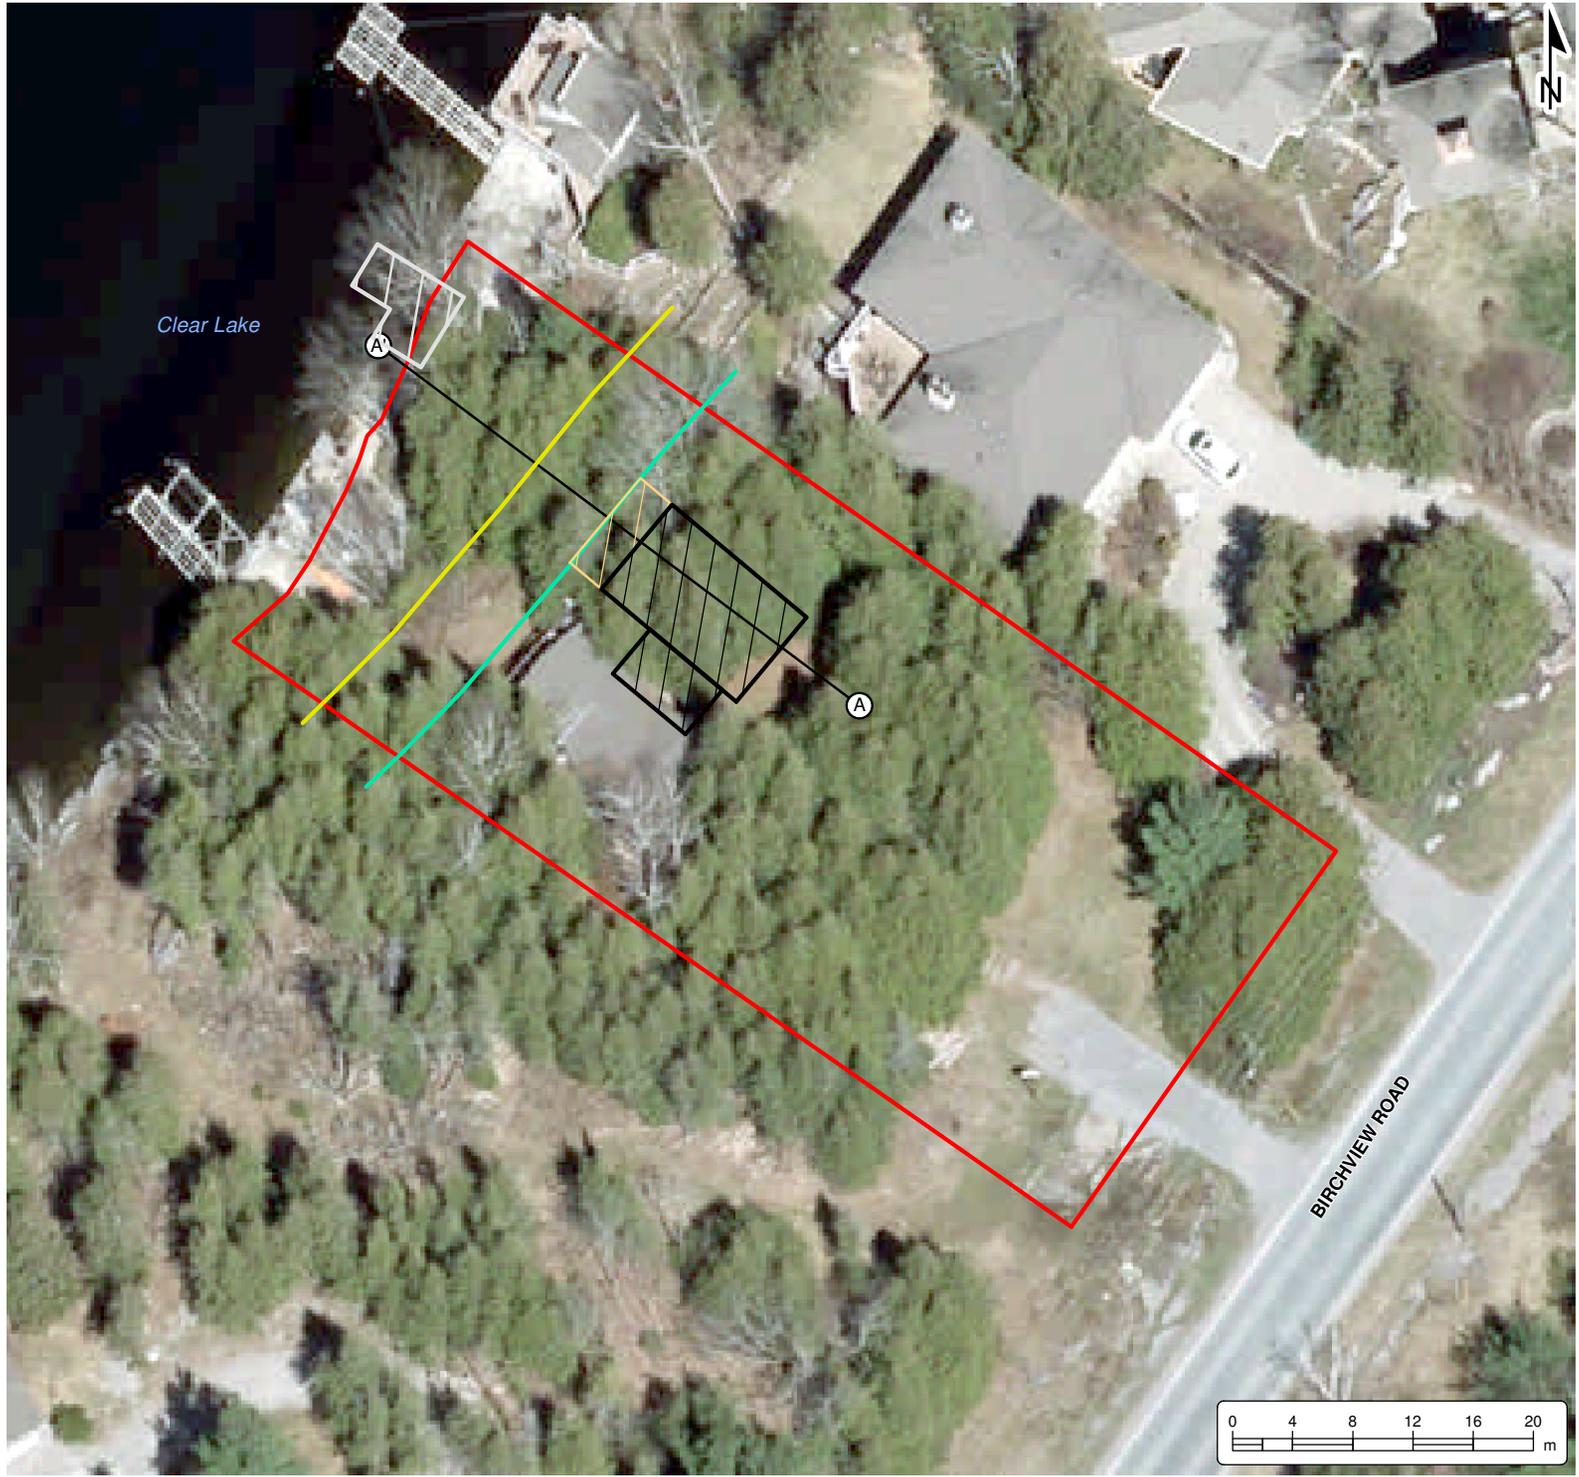
SITE PLAN

The erosion hazard limit incorporates all three allowances in this scenario by applying a setback, equivalent to the sum of the toe erosion allowance and erosion access allowance, from the excavation point on the slope which is considered to be stable in its current state. This is illustrated in Figure 1 and Figure 2 as a 6 m setback from the point top of existing stable slope.

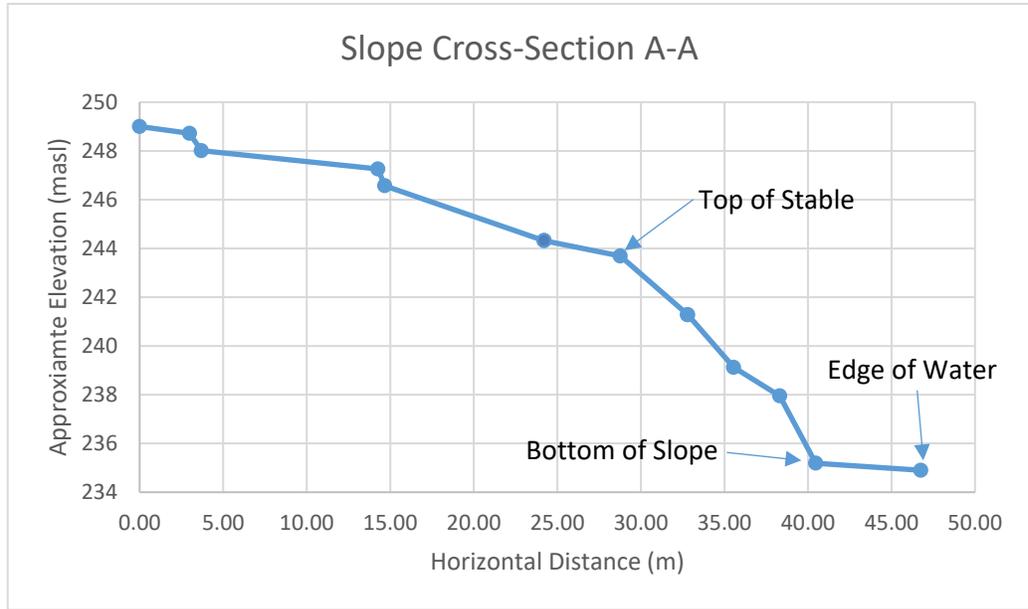
Figure 2: Cross Section A-A

elevation of 243.5 masl to 238.0 masl. The final section of slope is characterised by an inclination steeper than 1H:1V from an approximate elevation of 238.0 masl to 235.0 masl. The overall height of the slope is 14.1 m, although the client intends to construct the addition on bedrock between existing approximate elevations of 244.0 masl to 248.0 masl, 9.4 m above the base of the slope. These features are evident in the cross section presented in Figure 2.

As stated above, due to the presence of near-surface bedrock and the moderate inclination of the slope, there is no significant potential for immediate or sudden failure and any slope that is 1H:1V or less may be considered stable. As such, the point in the slope where the Client intends to excavate and level out the lot for construction is considered stable. The top of stable slope is then considered to be at the top of existing slope, is represented in Figure 2.

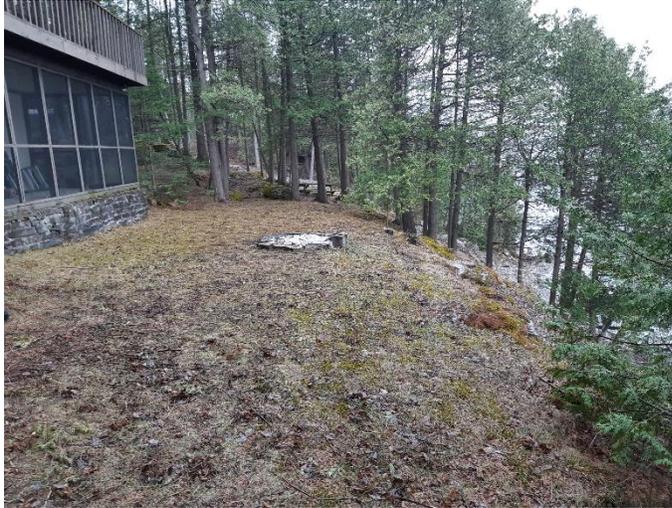
Photograph 1

Location:	Top of Main Slope Face
Viewing:	South West
Description:	Existing top of stable slope, table land conditions, existing residents.

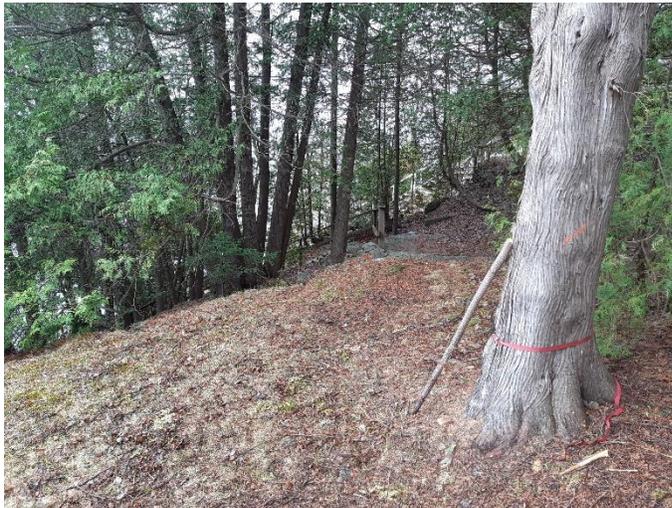
Photograph 2

Location:	Top of Main Slope Face
Viewing:	North
Description:	View of existing top of stable slope below proposed addition, staircase to waterfront and proposed boathouse visible.

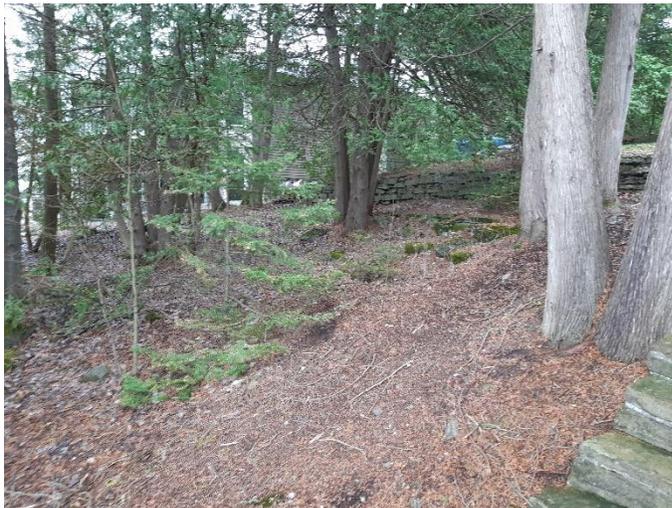
Photograph 3

Location:	Top of Main and Table Land
Viewing:	North East
Description:	Table land above top of stable slope, retaining wall for septic in location of proposed structure, neighboring house in proximity to slope.

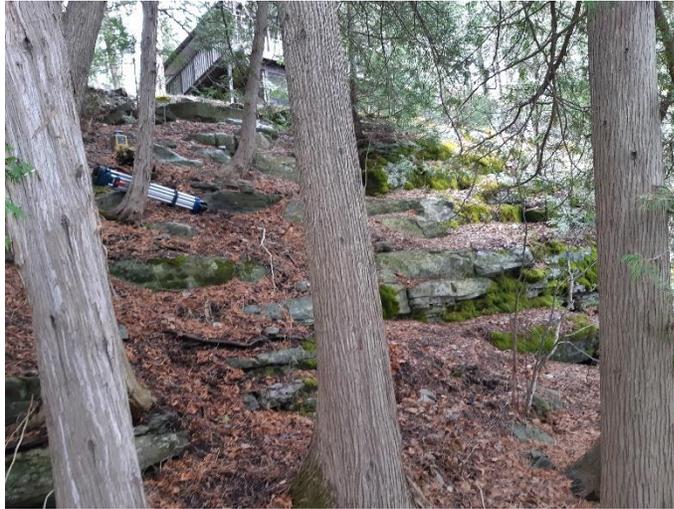
Photograph 4

Location: Middle of Slope

Description: Exposed limestone bedrock visible up the main slope face, mature trees, existing building above top of stable slope.

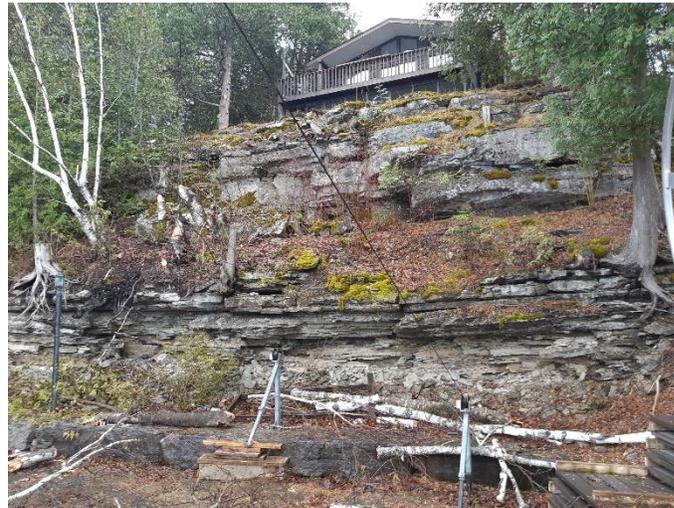
Photograph 5

Location: Bottom of Main Slope

Description: Main slope, exposed bedrock to toe of slope visible.

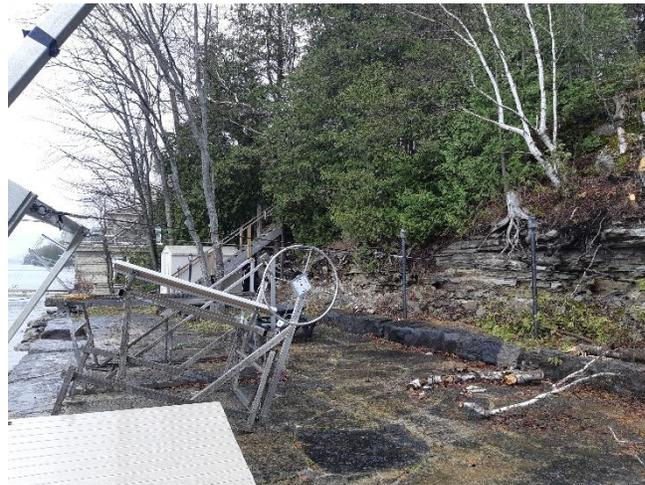
Photograph 6

Location: Bottom of Main Slope

Description: View of limestone patio at toe of slope, exposed bedrock above toe of slope, stair case down to shore. Shed in location of proposed boat house.

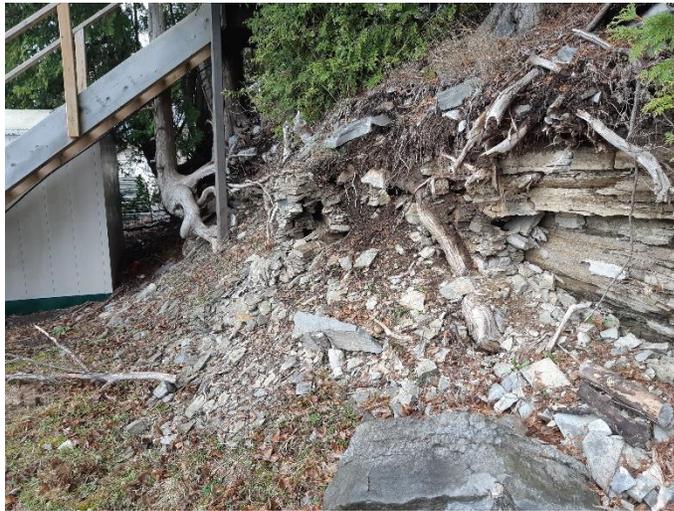
Photograph 7

Location:	Bottom of Slope
Viewing:	North East
Description:	Exposed limestone bedrock vertical face, minor erosion of topsoil and weather stone, cedar with exposed root system due to erosion of surficial soils.

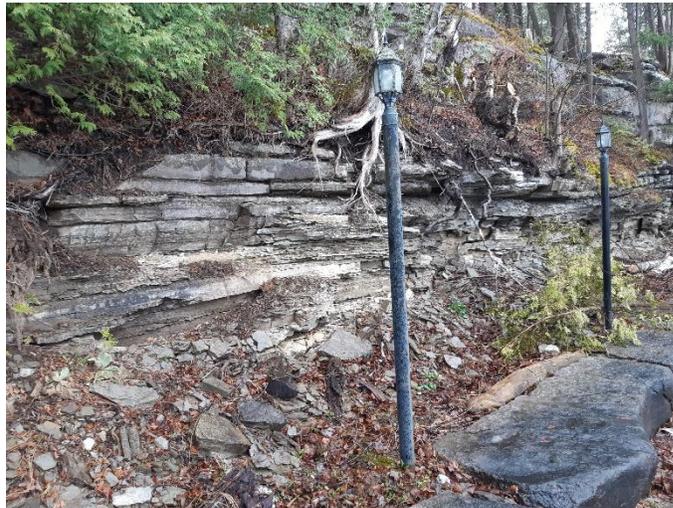
Photograph 8

Location:	Bottom of Main Slope
Viewing:	South
Description:	Main slope, exposed bedrock to toe of slope visible, evidence of minor topsoil and weathered stone erosion, armour stone present along back of patio.
