**Re: Scoped Environmental Impact Study at 912 Birchview Road,
Township of Douro-Dummer, County of Peterborough, Ontario**
Cambium Reference: 12708-001

**SITE NATURAL HERITAGE
FEATURES AND CONSTRAINTS**

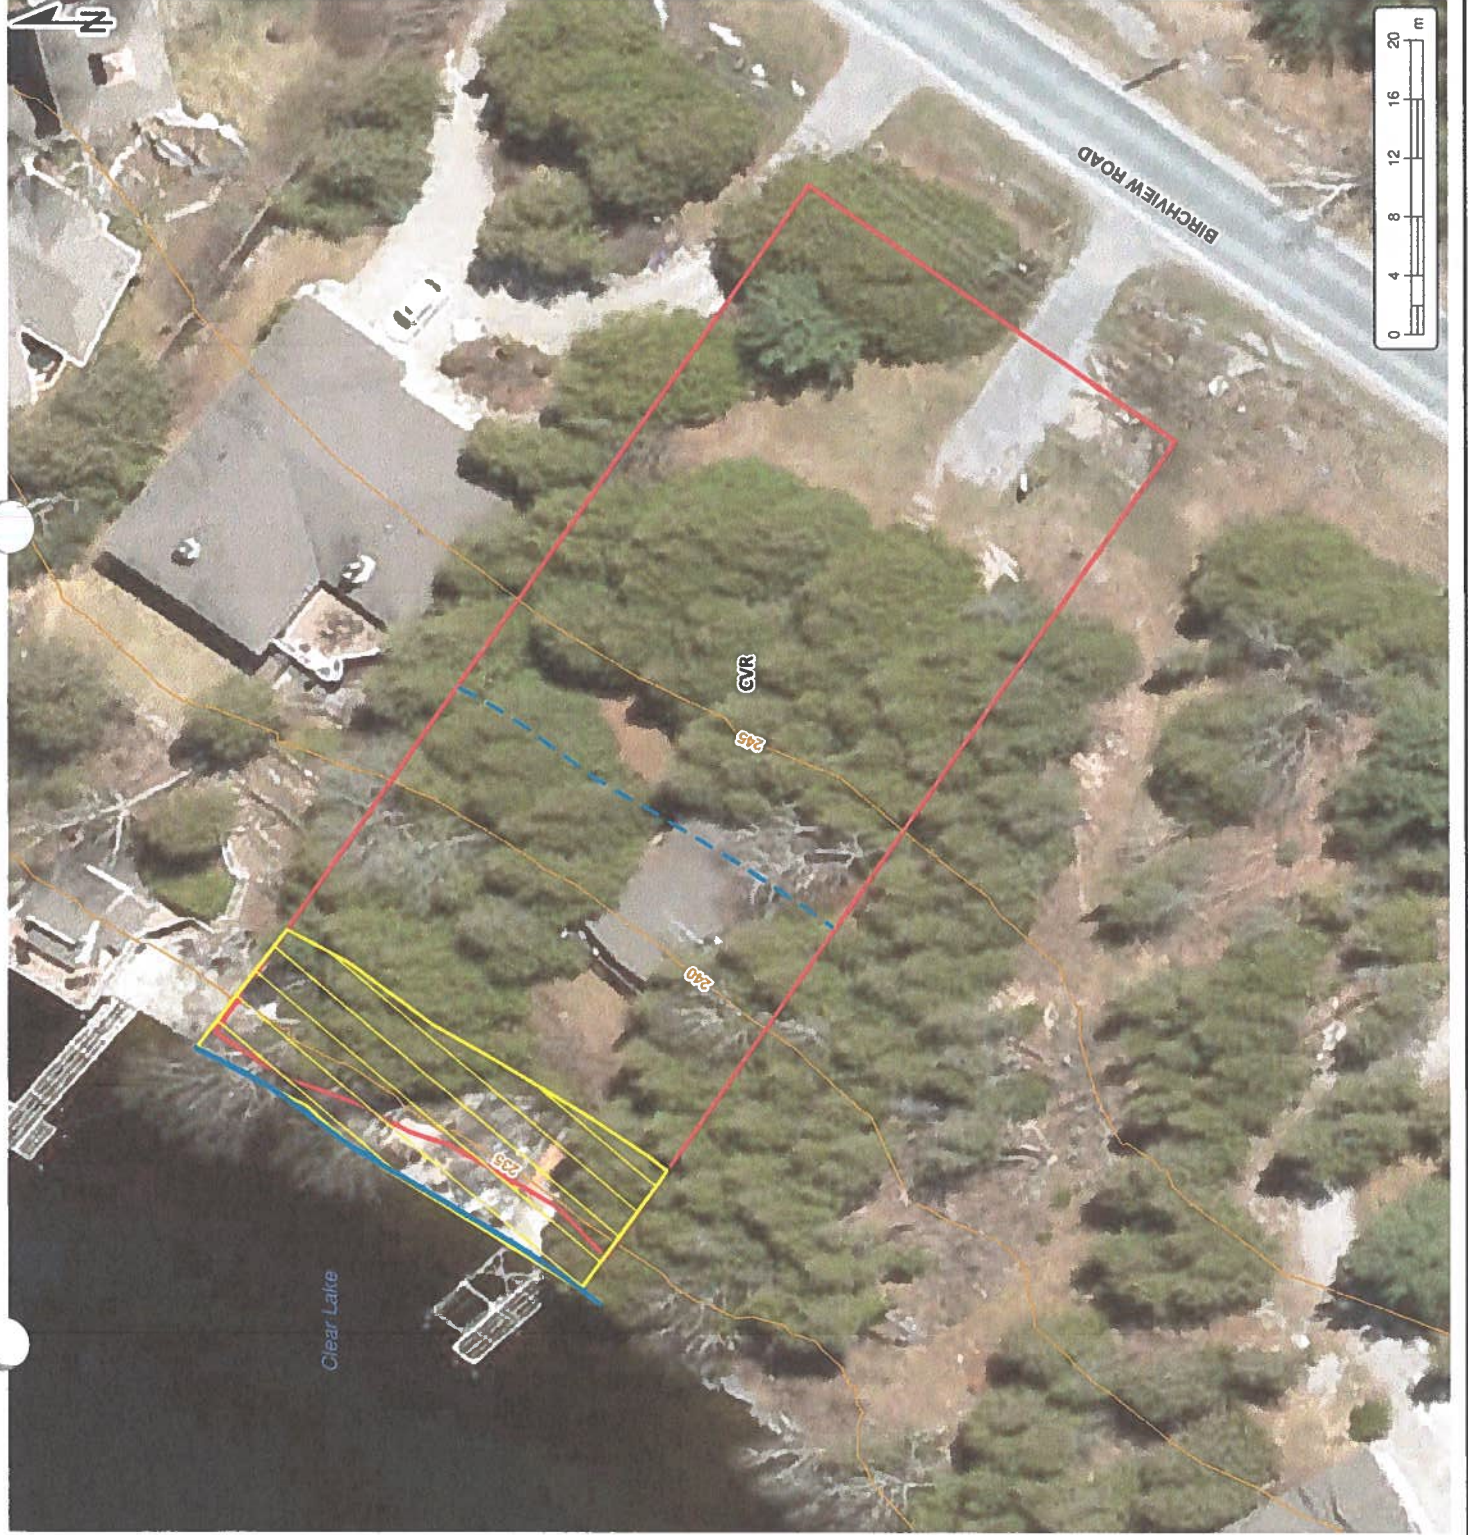
Project No.:	12708-001	Date:	August 2021
Scale:	1:500	Rev.:	
Projection:	NAD 1983 UTM Zone 17N	Created by:	MAT
Checked by:	ML	Figure:	1

A 30 m setback from the shoreline of Clear Lake is shown on Figure 1 (enclosed). The proposed addition and the boathouse, including the entirety of the existing dwelling, are located within the 30 m setback.

In addition, shoreline enhancement via planting of native shrubs within 10 m of the shoreline is recommended (see Figure 1). Native shrubs can be planted along the small terraces observed along the slope towards the shoreline as well as the upland area between the sloped area and the existing dwelling and proposed addition. Cambium recommends the following species and quantities:

16. It is recommended that the shoreline be enhanced through limitations on mowing within 5 m of the shoreline to allow for natural vegetation to regenerate, and through the planting of at least 20 native shrubs within 10 m of the shoreline and 10 native shrubs around the new boathouse, as detailed above and shown in Figure 1.

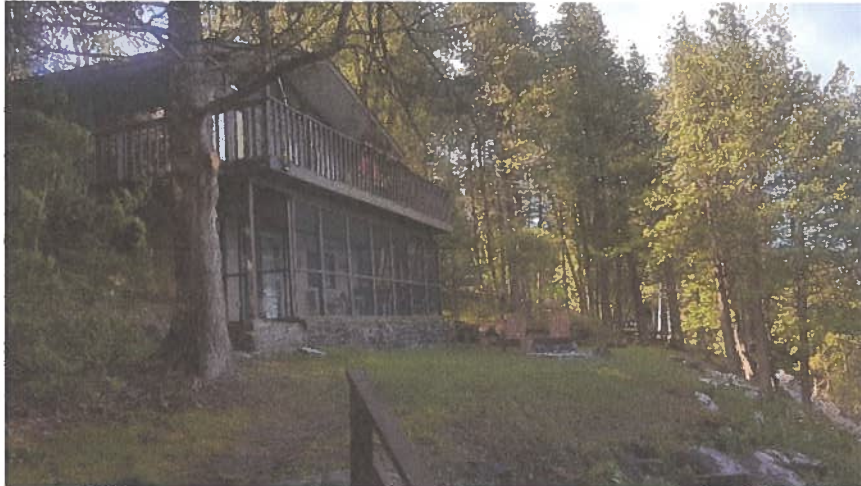
Photo 1 View of existing dwelling, June 22, 2021.

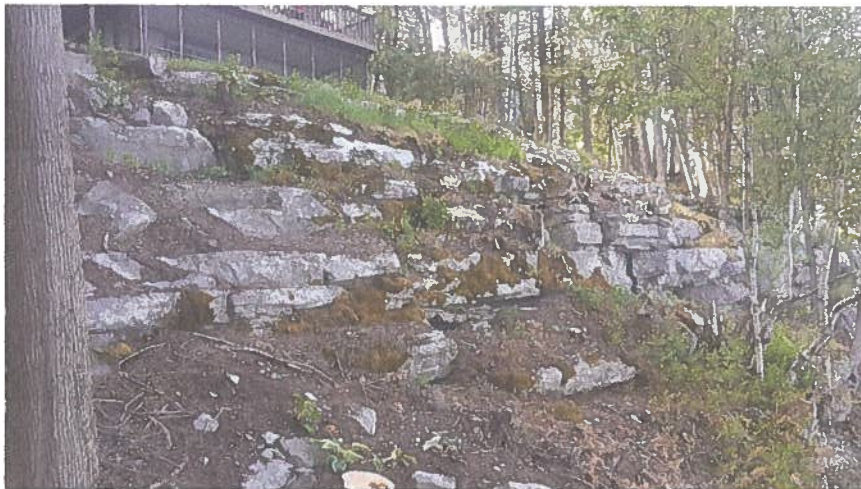
Currently, the shoreline and the associated 30 m setback consist of a terraced slope, with exposed bedrock and limited vegetation. The shoreline itself mainly consists of armour stone, with limited areas of manicured lawn. According to the GPGGH, lakes and their littoral zones require 30 m vegetation protection zones (VPZ). In order to provide a net benefit to the Site through shoreline enhancement and improve the VPZ, a Buffer Enhancement Plan/Landscape Plan is recommended. A few areas of manicured lawn were observed near the shoreline. It is recommended that mowing should cease within 5 m of the shoreline, in order to allow natural vegetation to regenerate. Trees within 5 m of the shoreline should be allowed to naturally self-sustain, providing natural cover to the shoreline as well as provide soil stabilization.

Photo 2 View of slope towards shoreline, June 22, 2021.

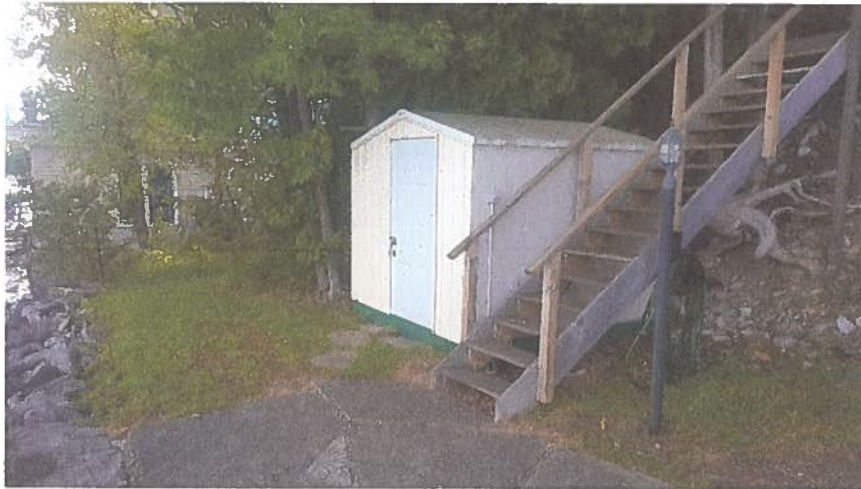
Photo 3 View of proposed boathouse location, June 22, 2021.

Additionally, another 10 shrubs should be planted surrounding the new boathouse. In particular, adjacent to the north and south walls of the structure.

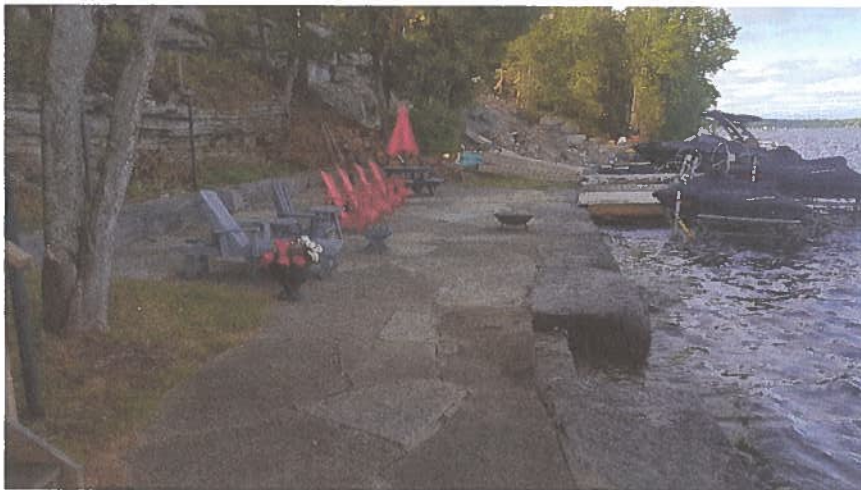
The entire shoreline area was hardened with armour stone and an adjoining stone patio. An area of manicured lawn approximately 15 m² in size surrounded the patio, adjacent to the shed. Several trees were observed along the northern boundary of the Site and within the steeply sloped area fronting the existing dwelling.

Photo 4 View of hardened landscaped shoreline, June 22, 2021.

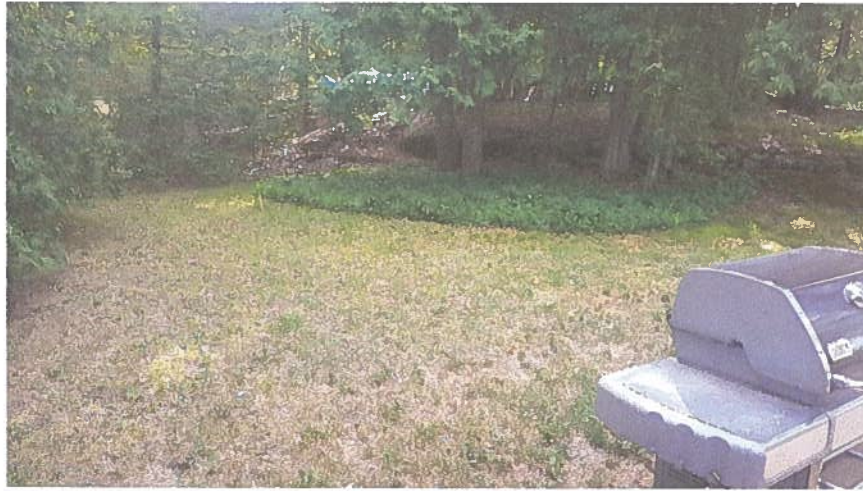
Vegetation on the Site consists primarily of maintained lawn with sparse trees (Eastern White Cedar, Paper Birch, and Silver Maple) and ground cover. Evidence of recent tree clearing was observed at the time of the field investigation. The existing land use was generally consistent with that of the neighbouring waterfront properties. The vegetation community occupying the Site was classified as Constructed Residential (CVR; see Figure 1).

Photo 5 General vegetation community present on Site, June 22, 2021.

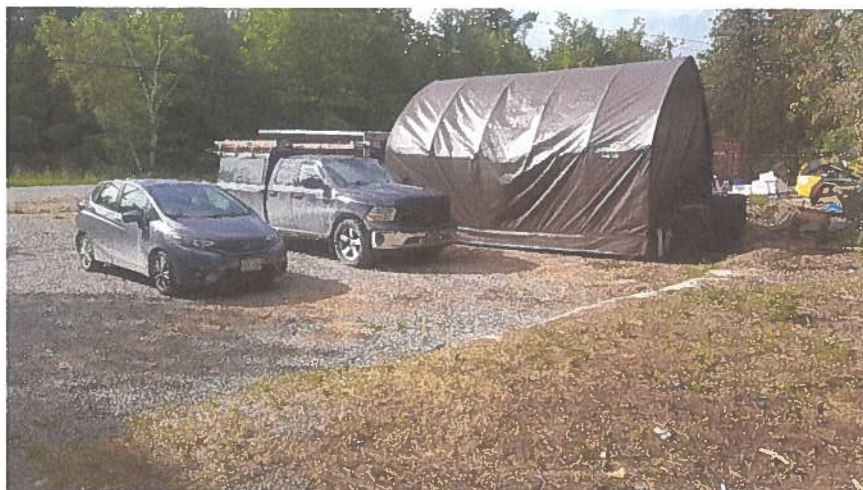
Photo 6 Existing gravel laneway, June 22, 2021.
