November 23, 2021

Re: Slope Stability Study – 426 Carveth's Marina Road, Lakefield
Cambium Reference: 12908-002

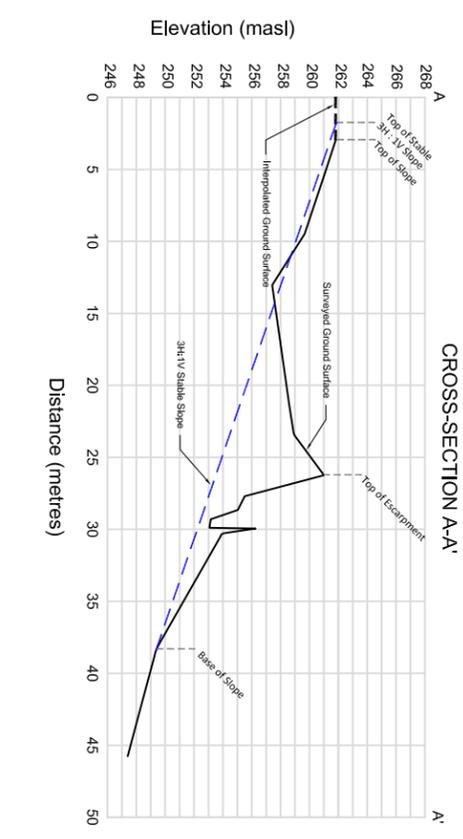
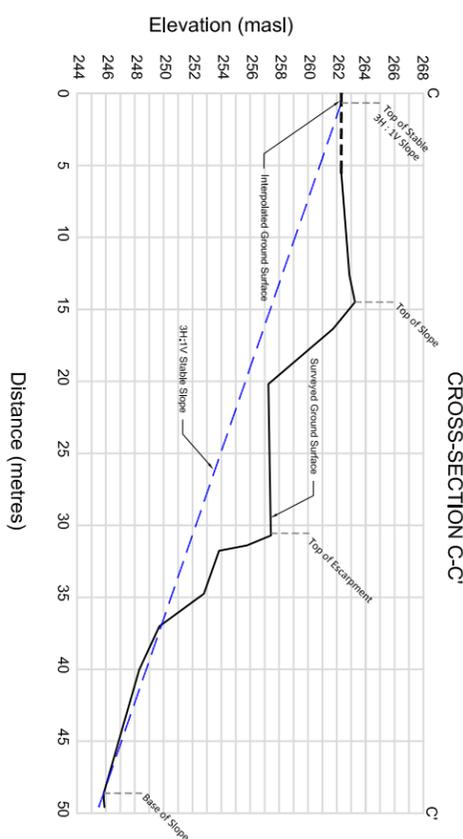
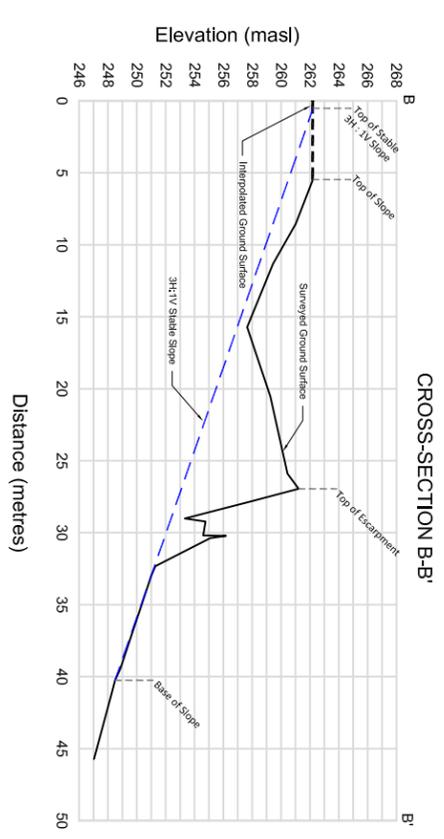
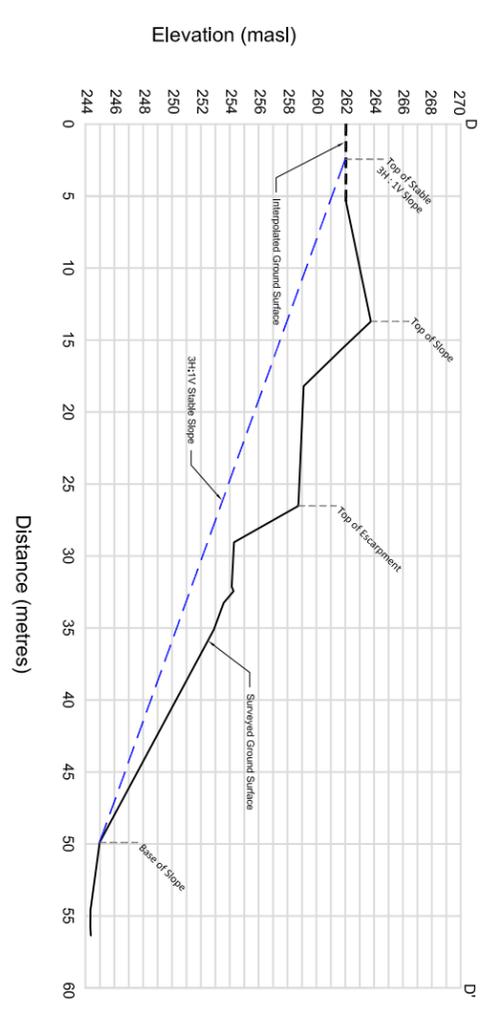
Project No.:	12908-002	Date:	November 2021
Horizontal Scale:	1:500	Vertical Scale:	1:1
Drawn By:	TLC	Checked By:	BP
Figure:	2

The top of 3H:1V stable slope falls within the proposed lots to be severed and is illustrated in Figure 1 and outlined in the cross sections in Figure 2. The 3H:1V stable slope represents a conservative estimate of the southern limit for the erosion hazard limit and may be further reduced through more detailed mapping escarpment. It is Cambium's opinion that residential development proposed south of the top of 3H:1V stable slope as illustrated in Figure1, is safe and will have no impact on the slope and vice versa.
